INDOOR AIR QUALITY ASSESSMENT REPORT

**ENVIRONMENTAL INVESTIGATION
OFFICE OF MILITARY COMMISSIONS
CAMP JUSTICE — NAVAL STATION GUANTANAMO BAY, CUBA**

12 January 2016

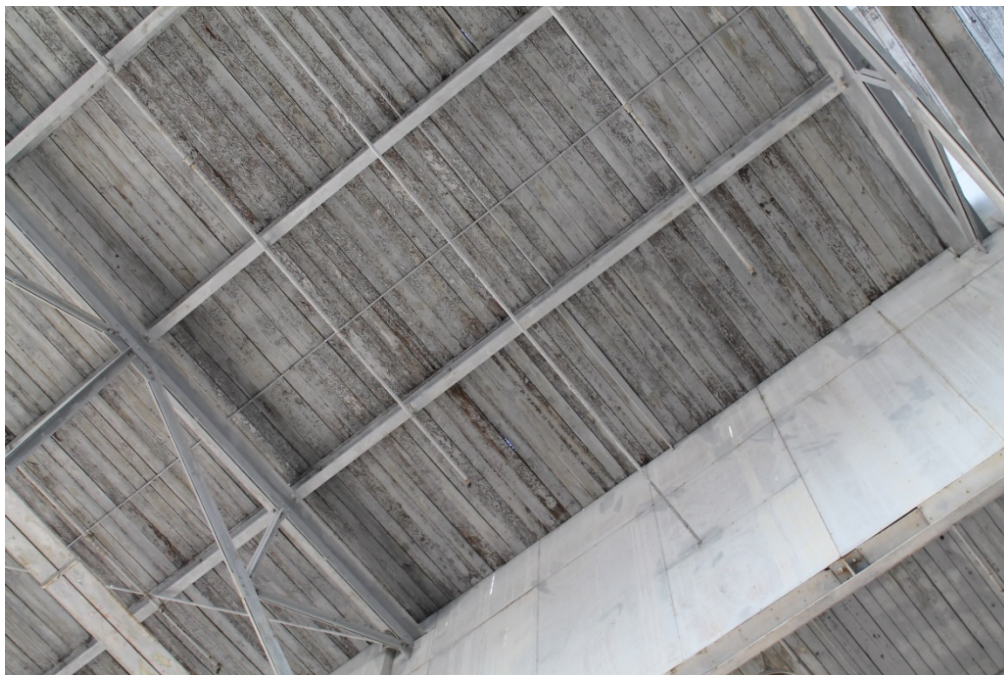
Resolution Consultants also observed paint chips on the hangar floor and paint scaling from the ceiling and some accessible wall surfaces. These painted surfaces were in poor condition, and reportedly contain lead (NS GTMO Public Works Department 2003).

Photograph 1: Scaling paint on AV32 ceiling.

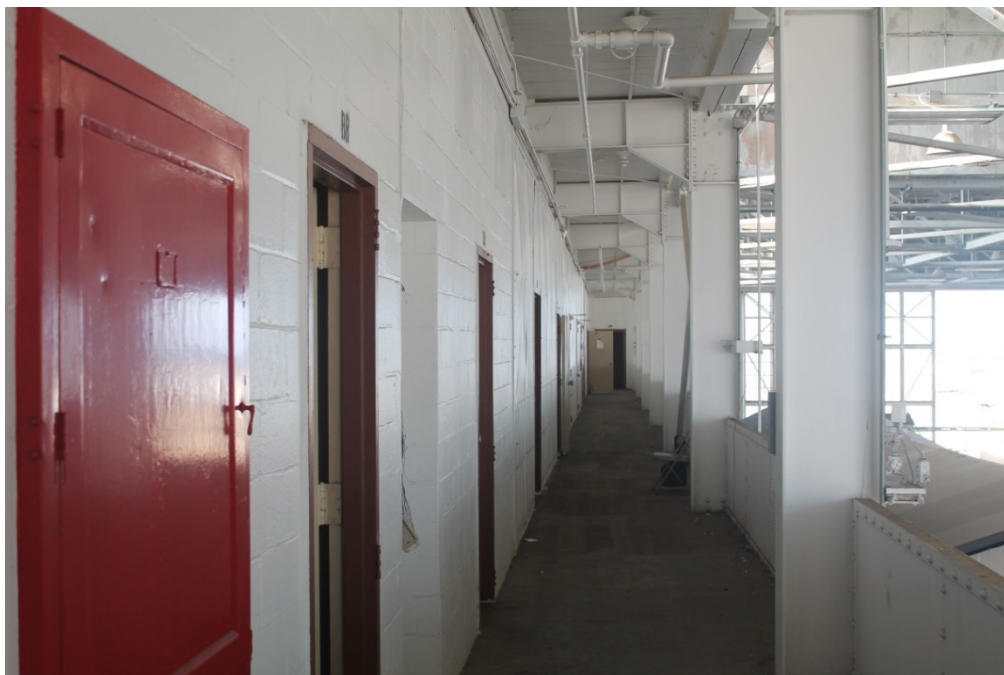
Resolution Consultants observed conditions within the interior of the building and within the three modular structures on the hangar floor. Resolution Consultants observed floor tile in poor condition on the mezzanine hallway along the west side of the building. Some of the tiles were loose with broken fragments observed. This floor tile was previously described as non-friable asbestos-containing material (Harmon Engineering Associates [Harmon] 1991. Other observations, including vermin droppings, dirt, and debris on the floor in the accessible offices, indicated poor housekeeping. The mezzanine hallway and accessible offices on the east side of the building had painted concrete floors in good condition. Housekeeping appeared to be adequate in those rooms.

Photograph 2: AV32, west 2nd floor mezzanine. Tile chips and debris.

- Perform airborne asbestos sampling in AV32. Due to the condition of the floor tile on the second floor west mezzanine, airborne asbestos sampling should be performed to determine if the asbestos is properly contained and managed.

- Review the O&M plan for the previously identified asbestos floor tile present in AV32. The observed condition of the vinyl floor tile indicates that the O&M plan recommended by Harmon has not been fully implemented.

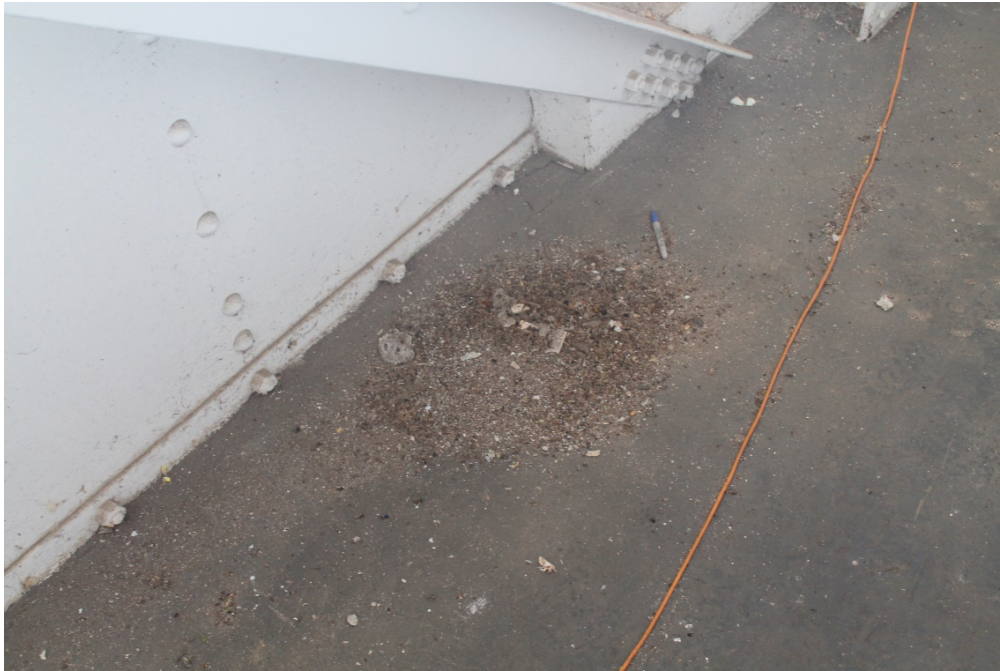
Photograph 3: AV32 mezzanine-pile of loose paint chips and other debris.

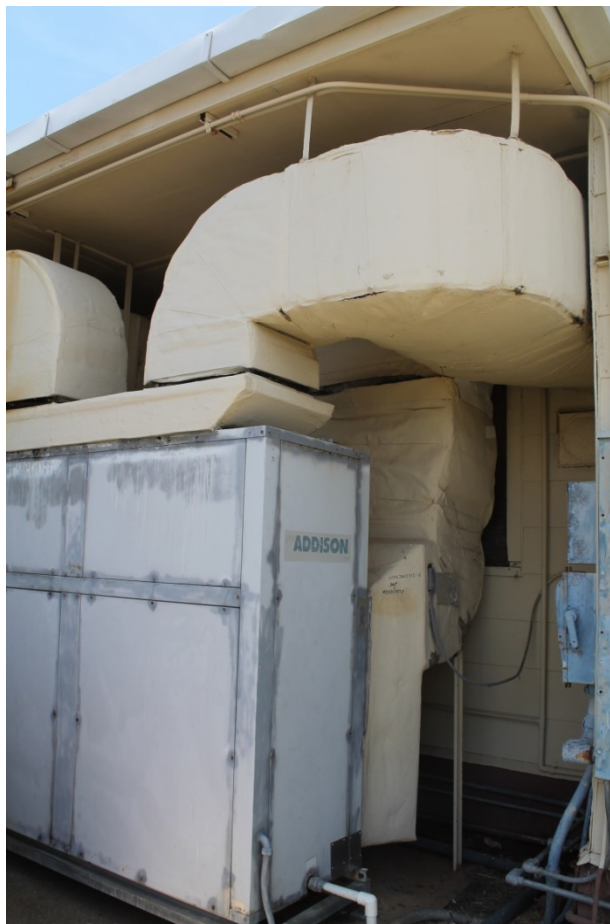
- Check the drainage system for the AV29 first floor air handler to verify that it is functioning correctly. The high average relative humidity measured on the first floor of AV29 indicates that the first floor air handler may not be draining condensate efficiently.

Photograph 4: AV29 first floor air handling unit.

- Check the drainage system for the AV29 first floor air handler to verify that it is functioning correctly. The high average relative humidity measured on the first floor of AV29 indicates that the first floor air handler may not be draining condensate efficiently.

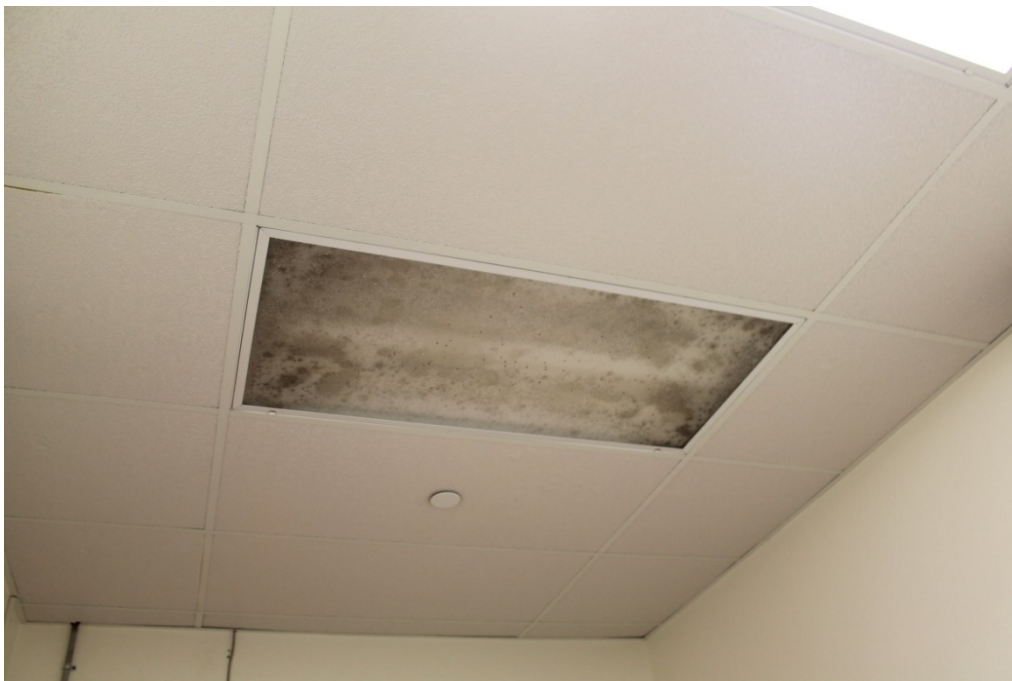
Photograph 5: Visible suspect microbial growth in ceiling light cover in AV29.

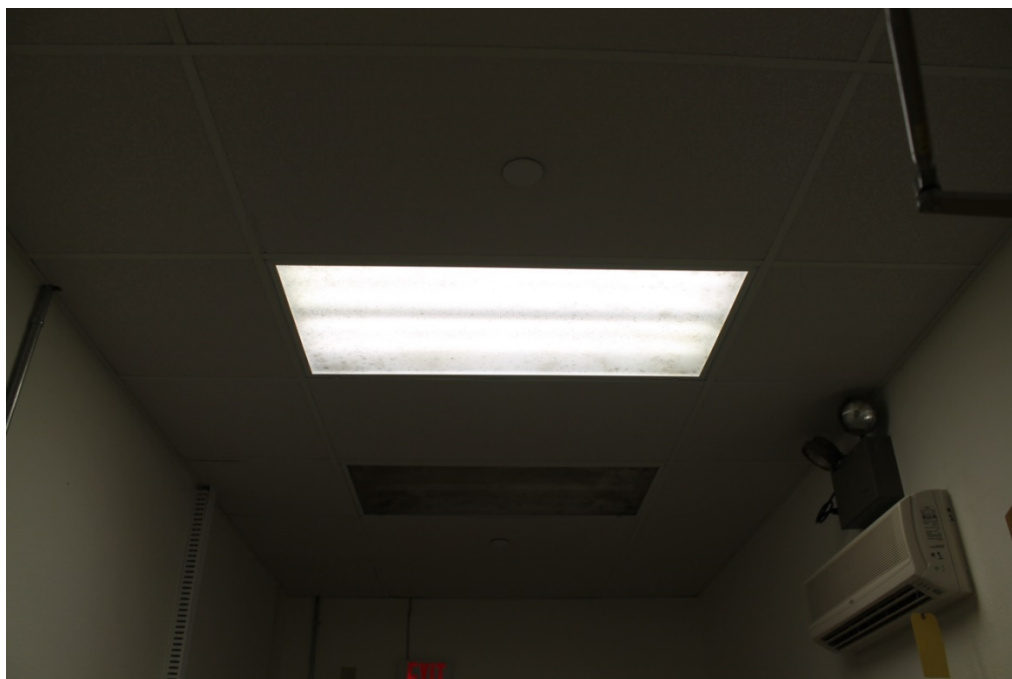
- Water-stained ceiling tiles were observed in Room 10 of AV34.
- Condensation was observed on some plastic ceiling light covers in AV29 and AV34 offices indicating excessive moisture in those areas.

Photograph 6: Condensation in ceiling light cover in AV34.

- Remove and clean the plastic ceiling light covers in AV34. Evaluate whether the moisture buildup could be due to a vapor barrier being created by the insulation used above the drop ceiling.

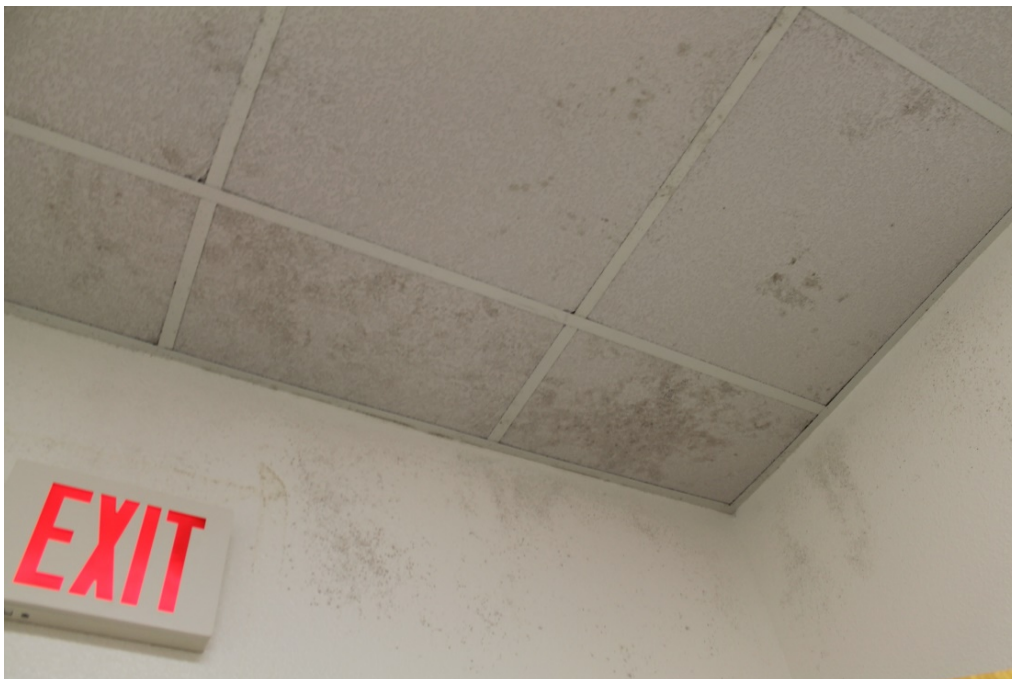
Resolution Consultants observed condensate in the ceiling light covers in the room adjacent to Courtroom I. A musty odor was noted, and the floor felt spongy in that area. Access above the drop ceiling revealed an approximately 3-inch layer of fiberglass insulation across the top of the 1-inch fiberglass drop ceiling material. An additional 3 inches of insulation were observed stapled to the underside of the second floor, approximately 2 feet above the drop ceiling. VSMG was observed on the upper wall of the room adjacent to Courtroom I and in the light fixture in Room 200. Condensate was also observed on the ceiling light cover in the Command Liaison Officer (CLO) Director's Office. Three water-stained ceiling tiles were observed in the detainee room on the north side of the building.

Photograph 7: Visible suspect microbial growth in AV34 ceiling area.

- Clean the VSMG observed in the first-floor utility closet in AV29, on the ceiling and wall in the room adjacent to Courtroom I in AV34, and in the light fixture in the CLO Director's Office in AV34 with water and a detergent solution, then vacuum with high-efficiency particulate arresting filtered equipment after the areas dry.

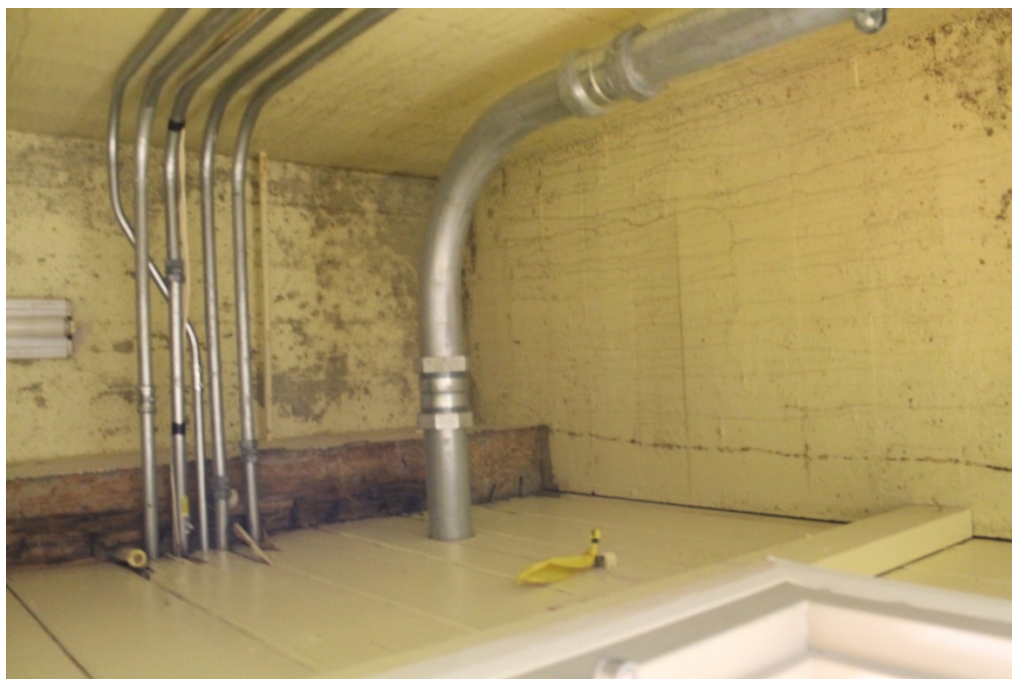
Resolution Consultants observed the accessible portions of the central air conditioning units at AV29. The interior unit that services the second floor had a maintenance tag affixed that indicated the filter had been changed within the past three months. A similar tag was not observed on the outdoor unit that services the first floor. The air supply was ducted to registers in the ceiling near the center of the offices with air returns in the hallway ceiling. Access above the dropped ceiling was obtained on the first and second floor. Resolution Consultants did not observe water stains or excessive dust buildup on the ceiling tiles. Visible suspect microbial growth (VSMG) was observed in the first floor utility closet.

Photograph 8: Visible suspect microbial growth in AV29 closet

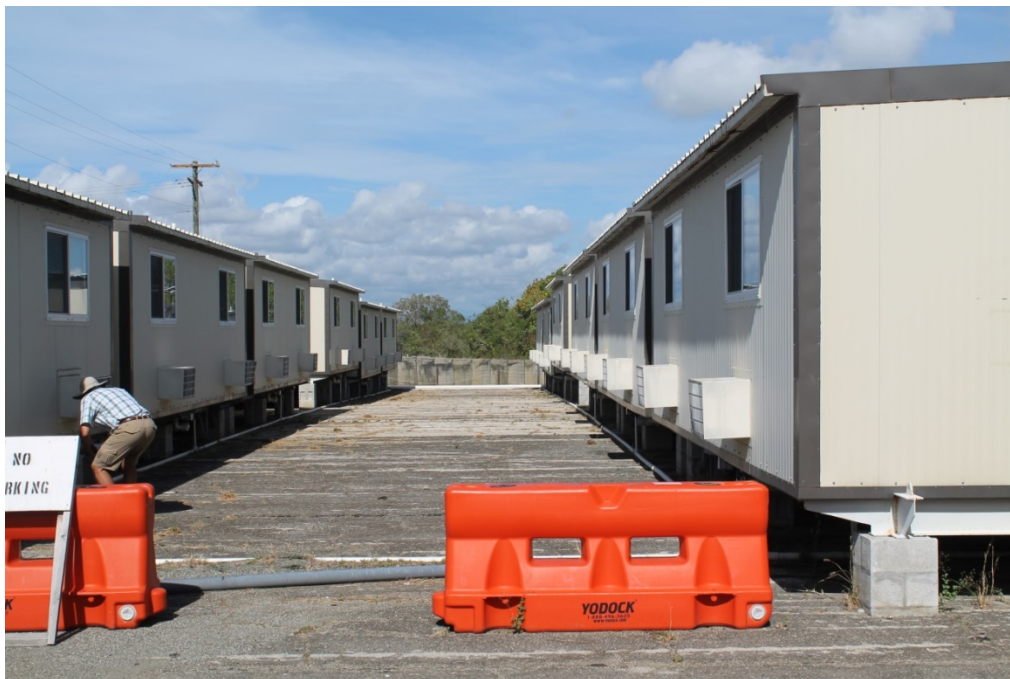
Photograph 9: Cuzcos.

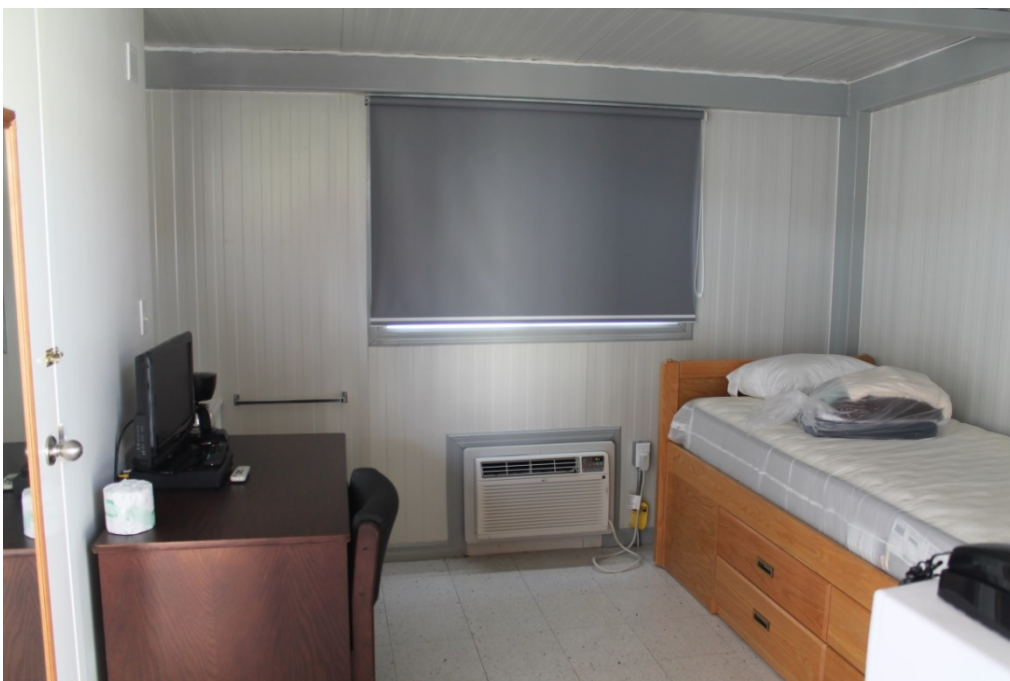
Photograph 10: Cuzco interior.

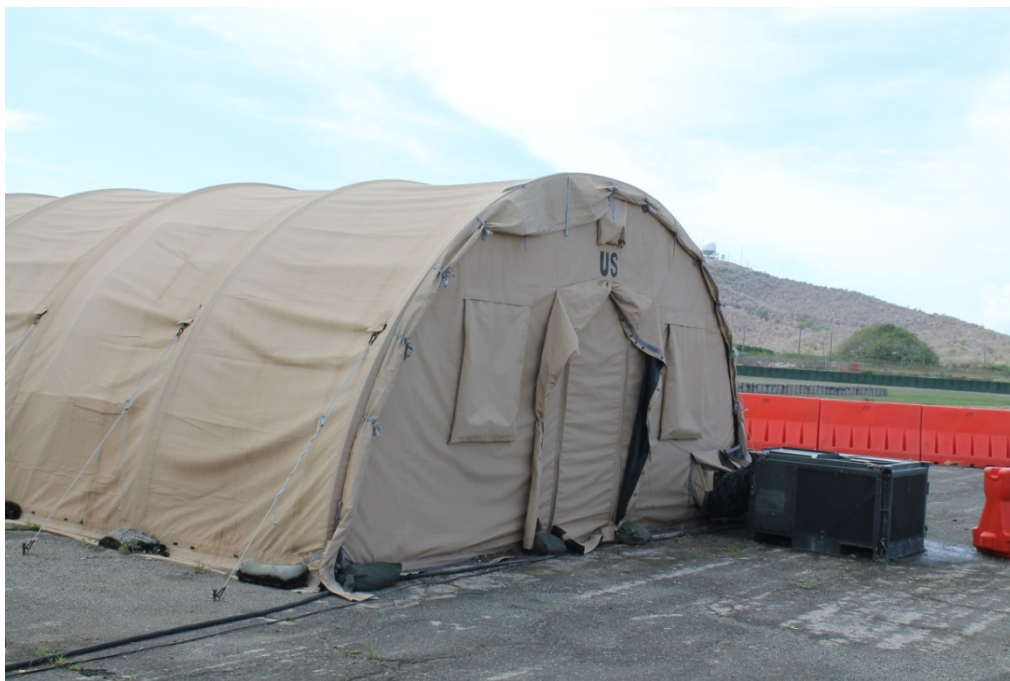
Photograph 11: Expeditionary tent

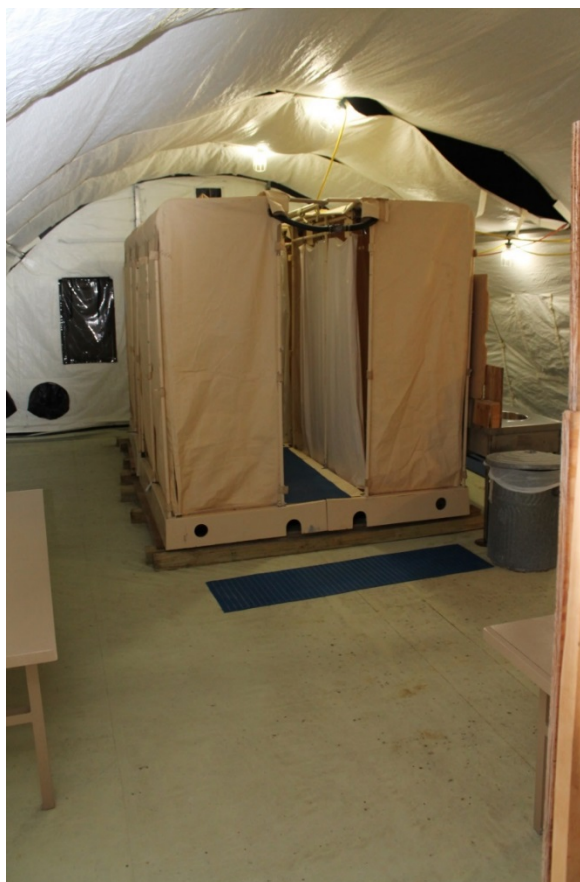
Photograph 12: Shower tent interior.
