# **INDOOR AIR QUALITY ASSESSMENT REPORT**

**ENVIRONMENTAL INVESTIGATION  
OFFICE OF THE MILITARY COMMISSIONS  
AREA OF OPERATIONS PATRIOT  
NAVAL STATION GUANTANAMO BAY, CUBA**

Resolution Consultants  
*A Joint Venture of AECOM & EnSafe*  
1500 Wells Fargo Building  
440 Monticello Avenue  
Norfolk, Virginia 23510

29 October 2015

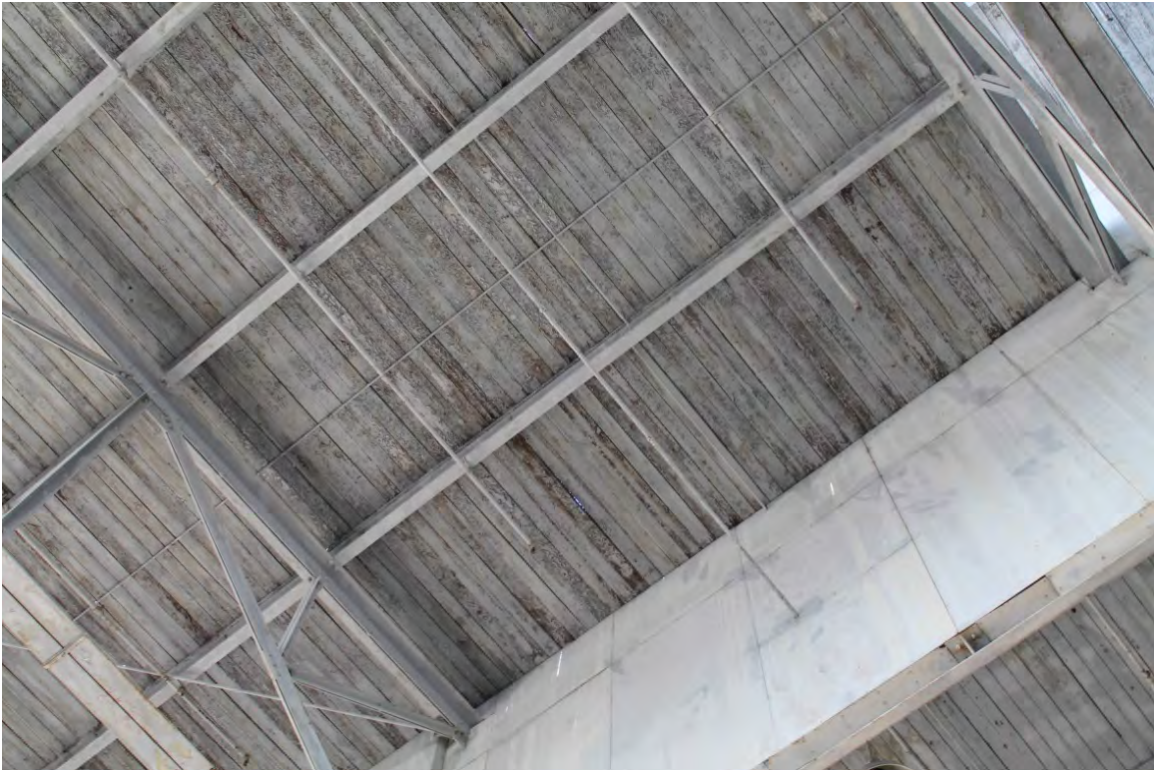
Resolution Consultants also observed paint chips on the hangar floor and paint scaling from the ceiling and some accessible wall surfaces. These painted surfaces were in poor condition, and reportedly contain lead paint as identified in a September 2004 report from Harmon Engineering Associates (Project # 1093-023-110).

**Photo 1:**      Scaling paint on AV32 ceiling.

2. Review the Operations and Maintenance (O&M) plan for the previously identified asbestos floor tile and Lead paint present in AV32. The observed condition of the vinyl floor tile and painted surfaces indicates that the O&M plan recommended in the 2004 report is not fully implemented.

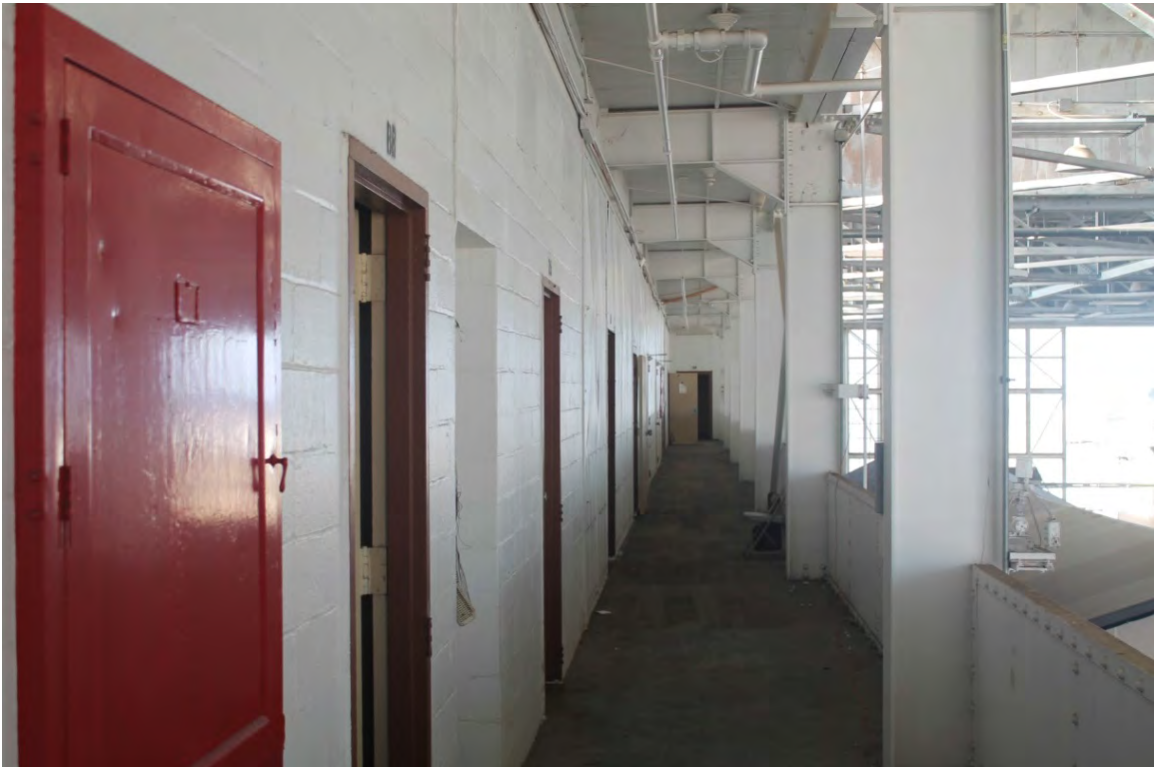
- The floor tile on the second floor, West mezzanine of AV32 was in poor condition with many broken tiles, and tile chips observed. These floor tiles were previously identified as non-friable ACM in the Harmon Engineering Associates report dated 23 September 2004. (Harmon Engineering Associates, 2004)
- Paint chips were observed on the floor of AV32. Paint was observed to be scaling off of the ceiling and accessible wall surfaces. Based on the Harmon Engineering Associates report dated 23 September 2004, this paint is assumed to contain Lead.
- The observed condition of the vinyl floor tile and painted surfaces in the West mezzanine of AV32 indicates that the O&M plan recommended in the Harmon Engineering Associates report dated 23 September 2004 is not fully implemented.

**Photo 2:**      AV 32, west 2<sup>nd</sup> floor mezzanine. Tile chips and debris.

1. Perform airborne asbestos sampling in AV32. Due to the condition of the floor tile on the second floor West mezzanine, airborne asbestos sampling should be performed to determine if the asbestos is properly contained and managed.

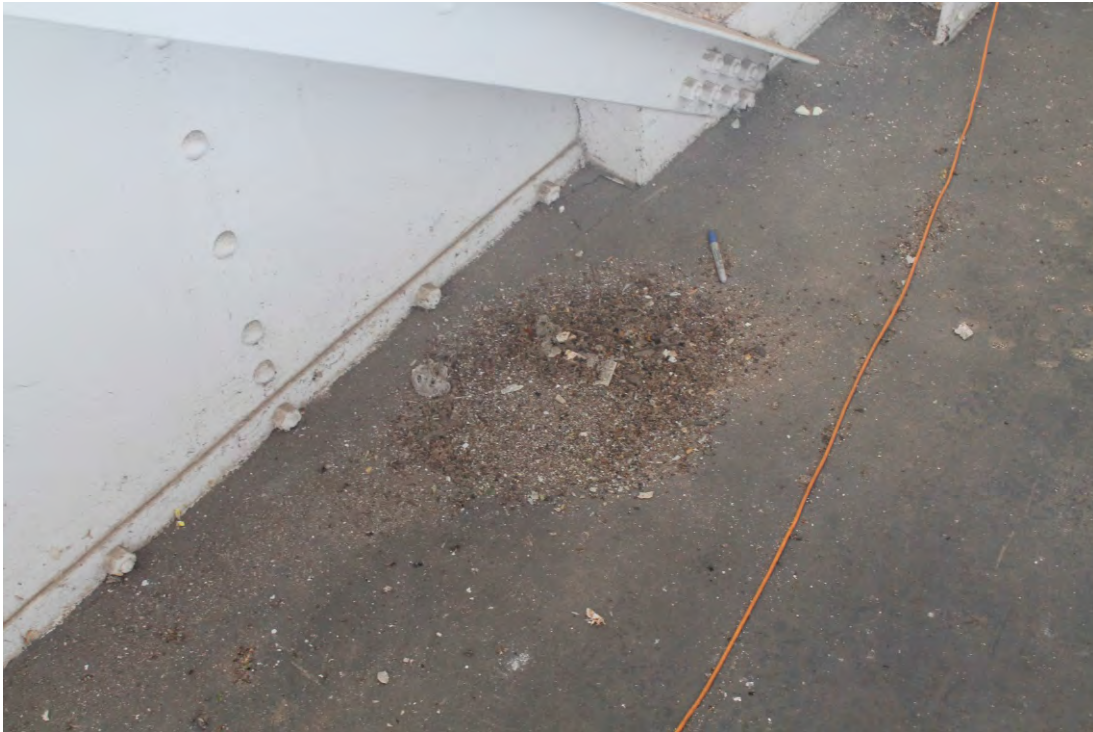
**Photo 3:** AV 32 mezzanine -pile of loose paint chips and other debris.

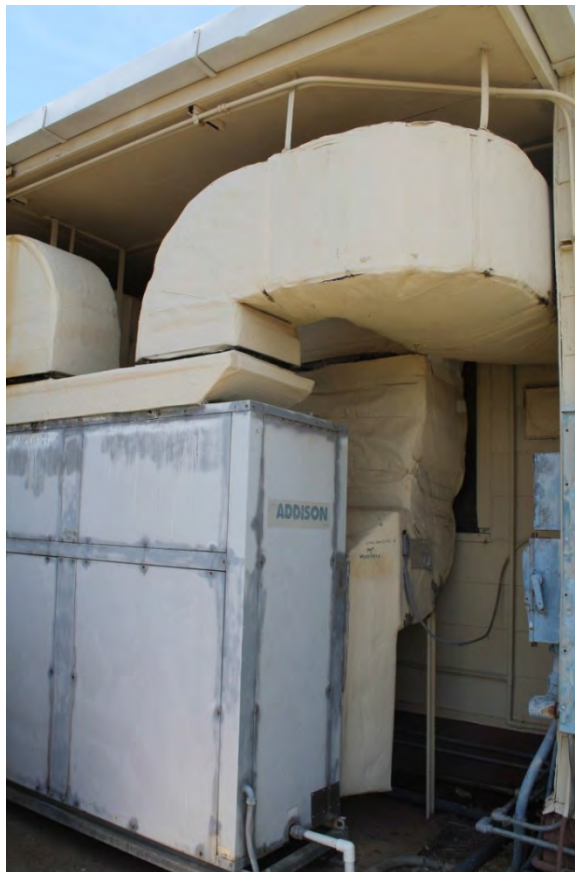
**Relative Humidity:** The relative humidity readings ranged from 48.4% to 79.7% throughout the rooms. Relative humidity measurements exceeded OSHA recommendations except for the Privilege Room. Also, relative humidity measurements on the first floor exceeded those on the second floor by about 10%.

**Photo 4:** AV29 first floor air handling unit.

6. Check the drainage system for the AV29 first floor air handler to verify that it is functioning correctly. The high average relative humidity measured on the first floor of AV 29 indicates that the first floor air handler may not be draining condensate efficiently.

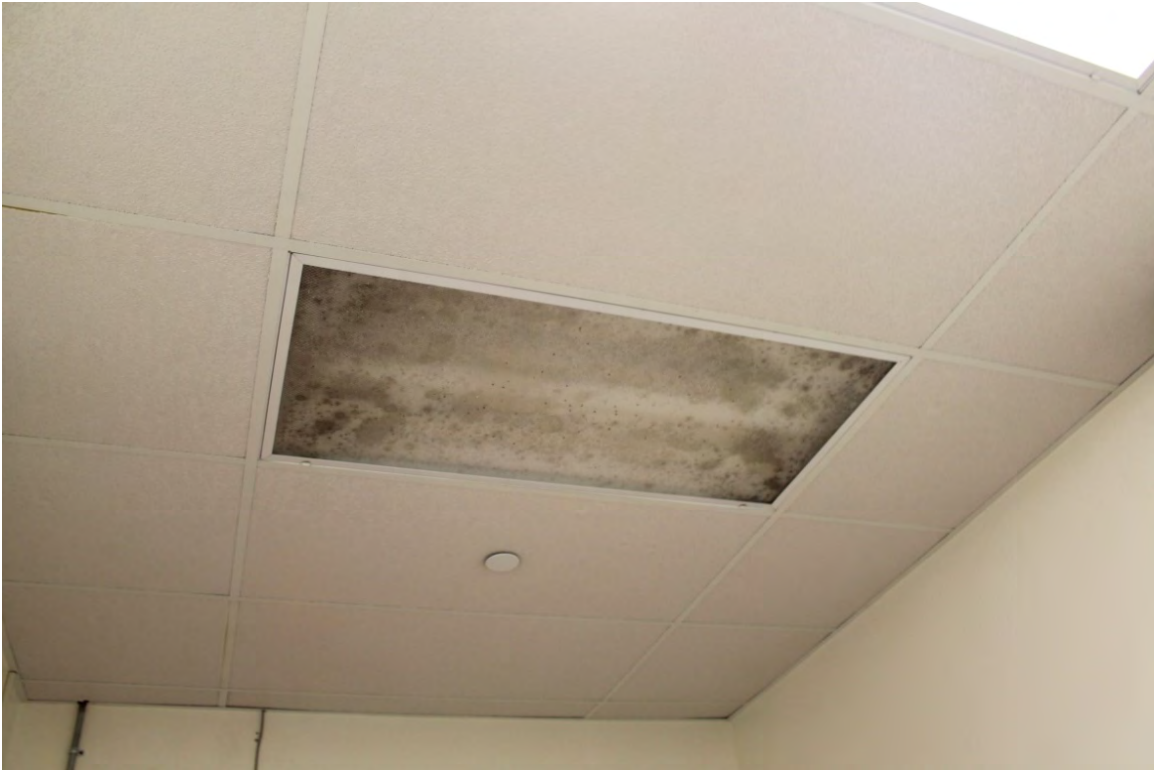
**Photo 5:** Visible suspect microbial growth in ceiling light cover in AV29.

5. Clean the VSMG observed in the closet in AV29, the room adjacent to Courtroom 11 in AV34, and in the light fixture in the CLO Director's office in AV34, with water and a detergent solution, and then HEPA-vacuum after the areas dry.

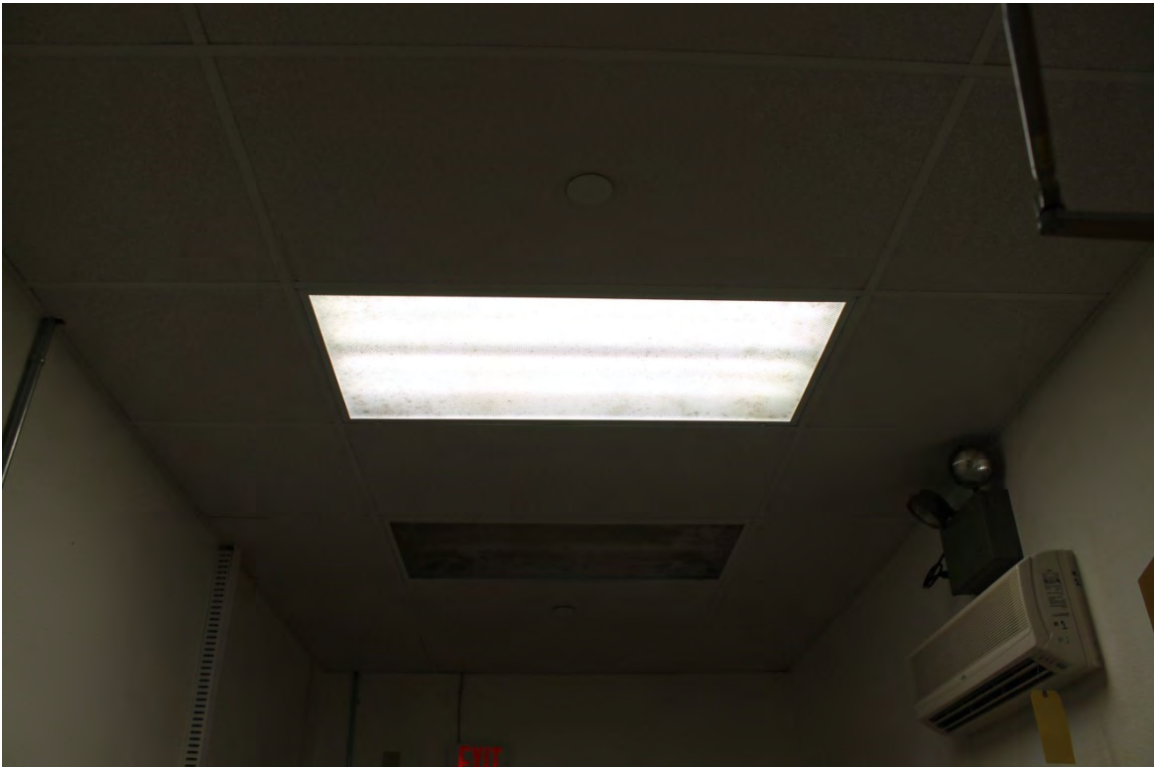
Resolution Consultants observed condensate in the ceiling light covers in the room adjacent to Courtroom I. A “musty” odor was noted, and the floor felt “spongy” in this area as well. Access above the drop ceiling revealed approximately three inches of fiberglass insulation lying across the top of the one inch fiberglass drop ceiling material. Approximately three additional inches of insulation were observed stapled to the underside of the second floor approximately two feet above the drop ceiling. Visible suspect microbial growth was observed on the upper wall of the room adjacent to the small courtroom (Courtroom I) and in the light fixture in Room 200. Condensate was also observed on the ceiling light cover in the Command Liaison Officer Director’s office. Three water-stained ceiling tiles were observed in the detainee room on the North side of the building.

**Photo 6:** Condensation in ceiling light over in AV34.

4. Remove and clean the plastic ceiling light covers in AV34. Evaluate whether the moisture buildup could be due to a vapor barrier being created by the insulation used above the drop ceiling.

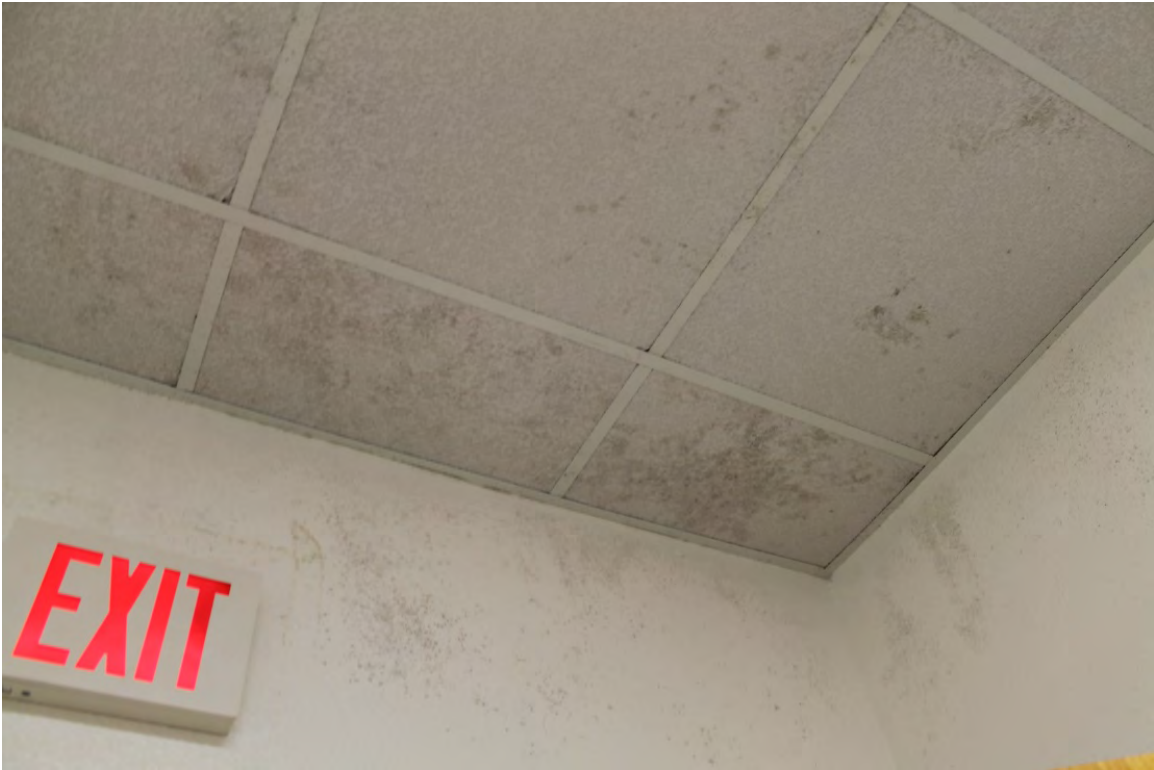
**Photo 7:** Visible suspect microbial growth in AV34 QRF ceiling area.

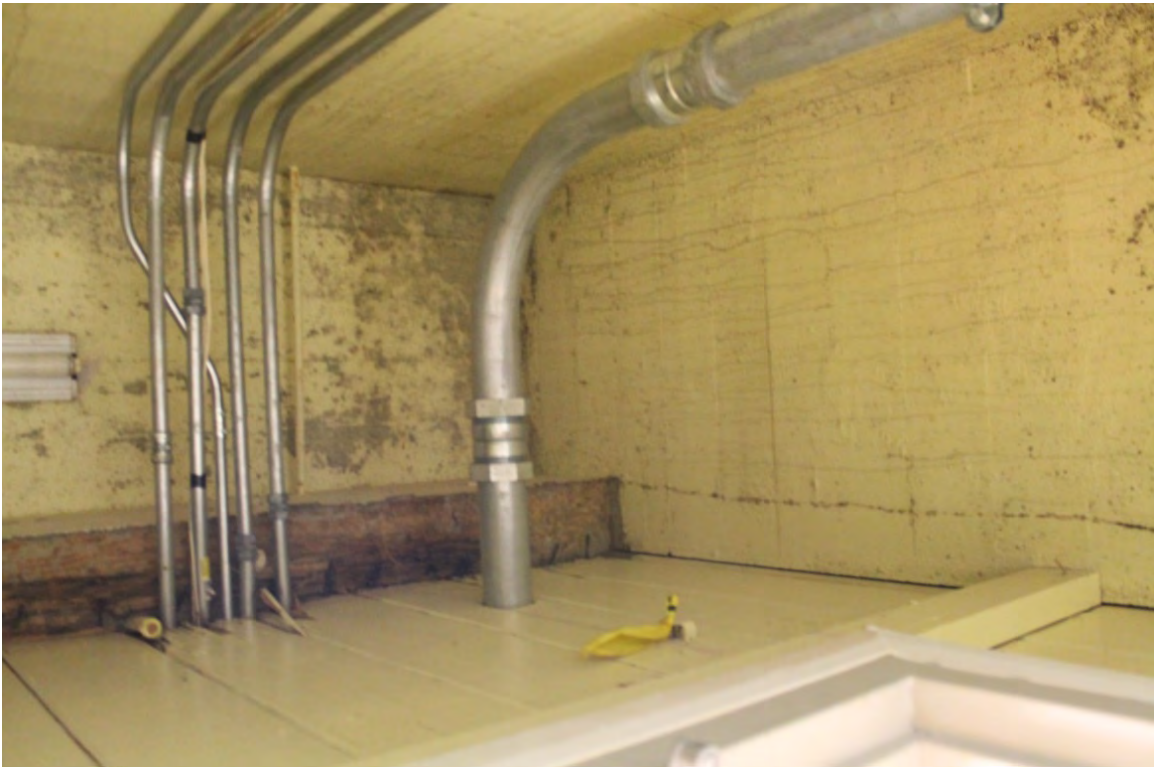
Resolution Consultants observed the accessible portions of the central air conditioning units. The interior unit that services the second floor had a maintenance tag affixed to the unit indicating that the filter had been changed within the last three months. A similar tag was not observed on the outdoor unit that services the first floor. The air supply was ducted to registers in the ceiling near the center of the offices with air returns in the hallway ceiling. Access above the dropped ceiling was obtained on the first and second floor. Resolution Consultants did not observe water stains or excessive dust buildup on the ceiling tiles. Visible suspect microbial growth (VSMG) was observed in the first floor utility closet.

**Photo 8:** Visible suspect microbial growth in AV29 closet

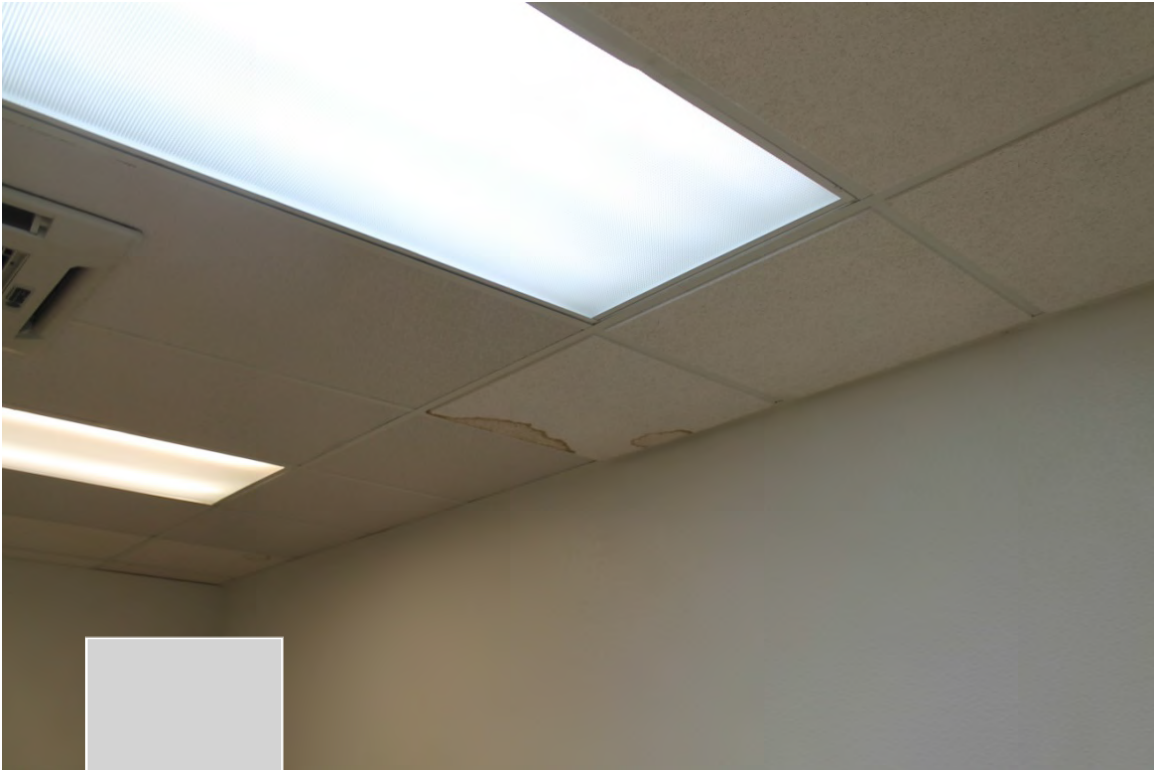
**Photo 9:** Stained ceiling tiles in detainee area of AV34.

3. Discard and replace water-stained ceiling tiles in Room 10 of AV34. Ceiling tile replacement should be conducted concurrent with the identification and elimination of water intrusion sources (i.e., pipe and roof leaks).
