Subj: BUILDING 1782 CHILD DEVELOPMENT CENTER AND OUTDOOR PLAY
AREAS DRINKING WATER

Priority Areas Lead Testing and Corrective Actions May 2019
NAS CORPUS CHRISTI Child Development Center Building 1782

LIPA Sampling Support 2019
NAS Corpus Christi

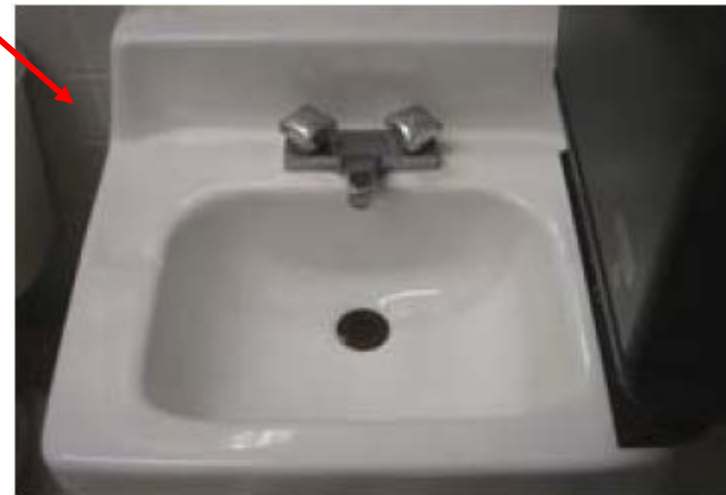
CC-1782-RM122-RM-LHWP-FD (BLDG 1782-16)

1. Building 1782, Child Development Center, Low Handwash sink in the Starfish Classroom 122. Result was 150 ppb.
2. Outdoor Play Area - Ball Field Bravo, Hose spigot. Result was 16 ppb.
3. Outdoor Play Area - Waldron Sports Field, Hose spigot. Result was 16 ppb.
4. Outdoor Play Area - Waldron Sports Field, Hose spigot. Result was 16 ppb.

We performed follow up sampling on 11 June 2019 to determine the source of the lead. All four fixtures have been replaced and final testing was conducted on 5 September 2019. All results were at or below the 15 ppb screening level and are returned to service.

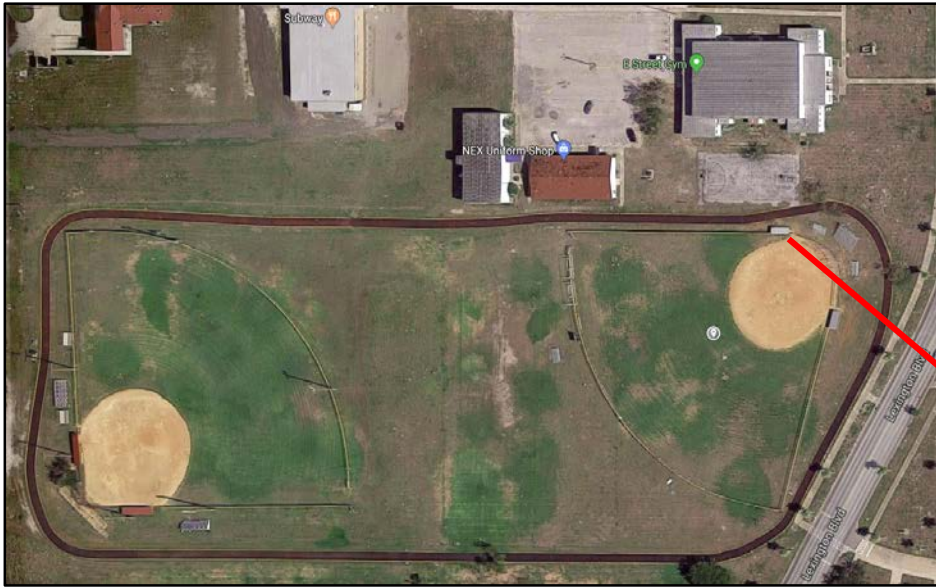
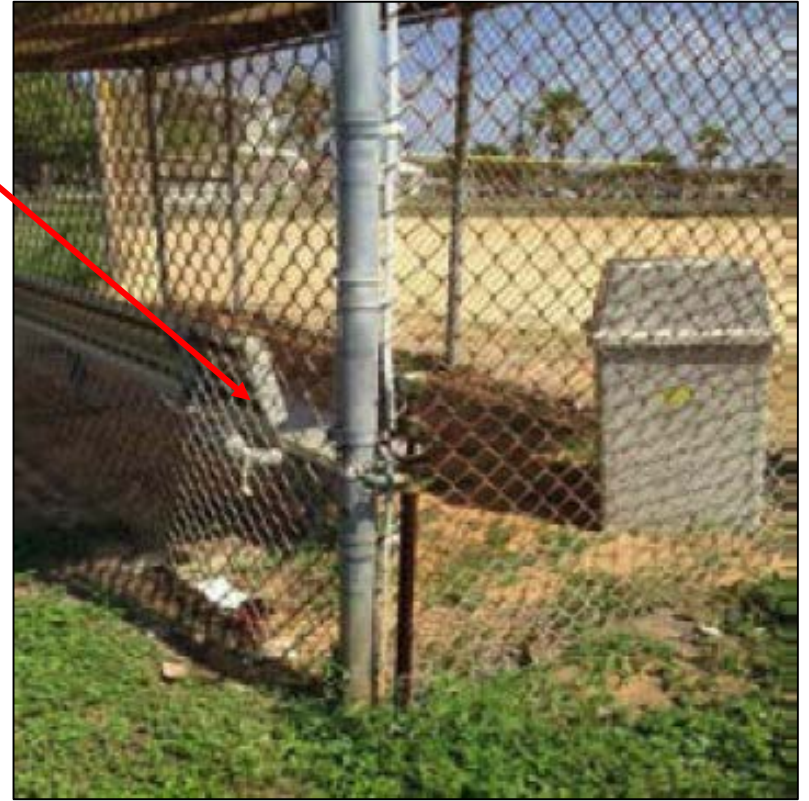
Figure 2

CC-PLAY-BRAVO-HOSECOMB-FD (OPA-5)

OPA-5 LIPA Exceedance Location

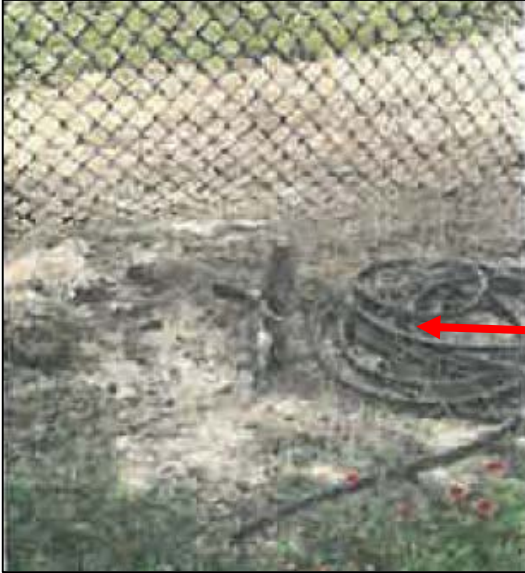
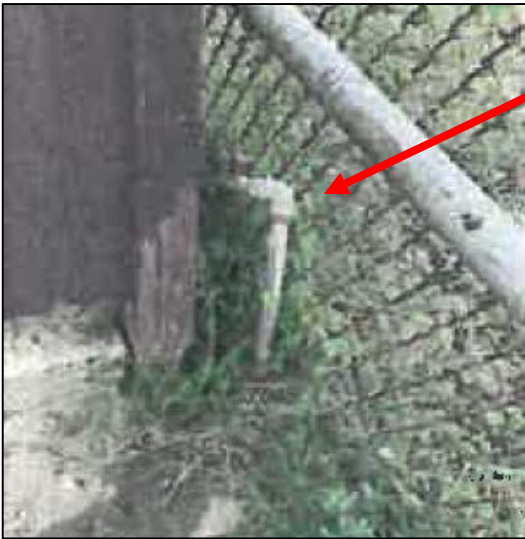
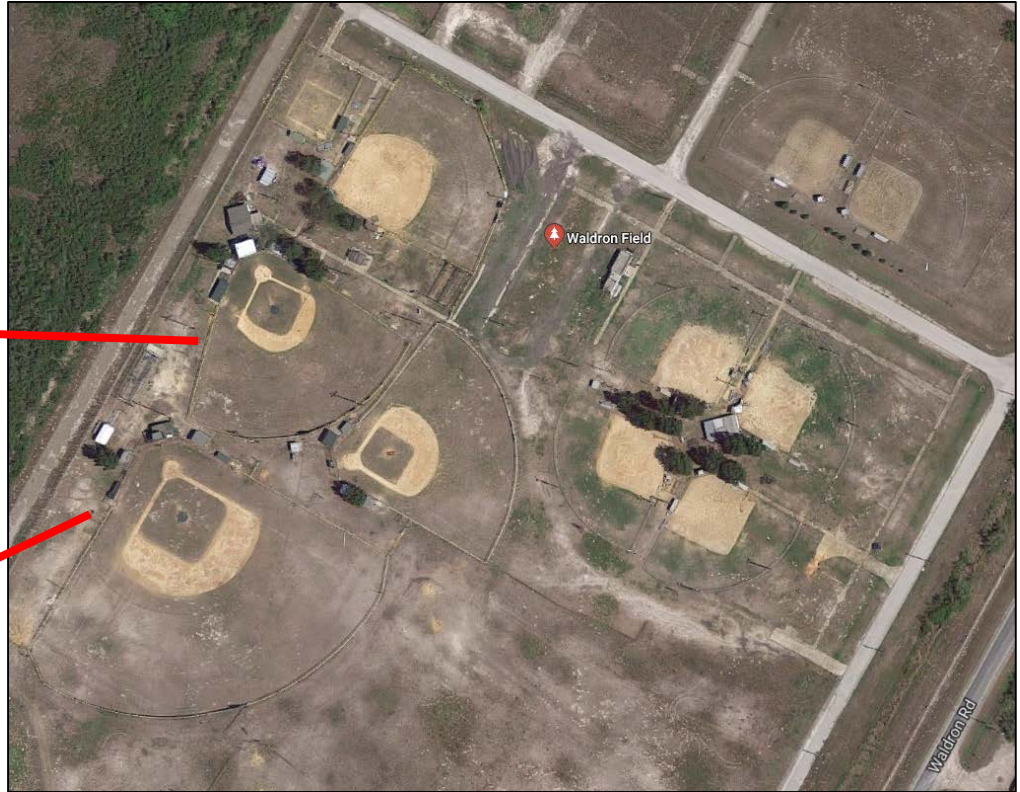
Figure 3

CC-PLAY-WALDRON-HOSE-I-FD (OPA-15)

CC-PLAY-WALDRON-HOSE-J-FD (OPA-16)

OPA-15 and OPA-16 LIPA Exceedance Locations

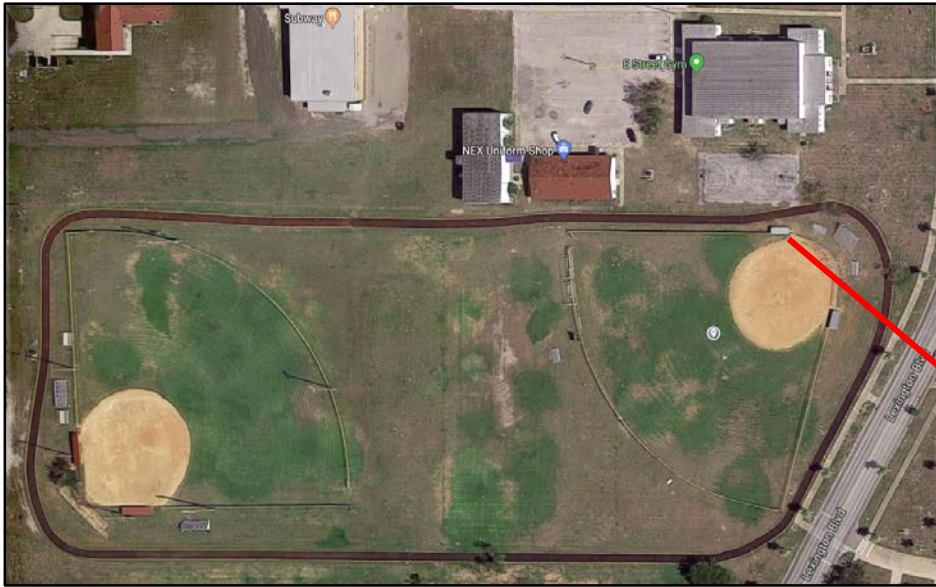
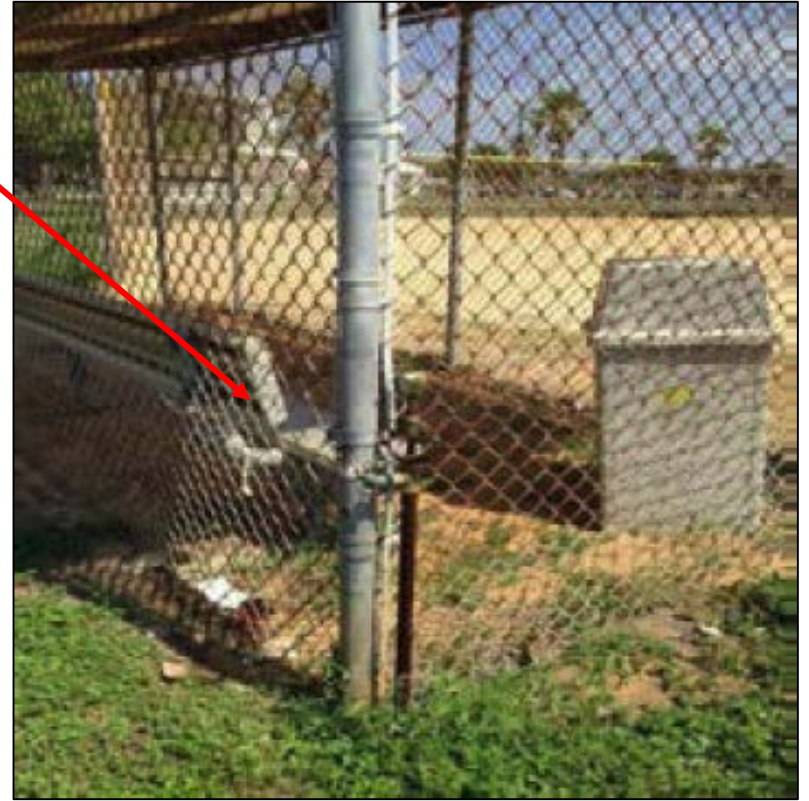
Figure 2

CC-PLAY-BRAVO-HOSECOMB-FD (OPA-5)

OPA-5 LIPA Exceedance Location

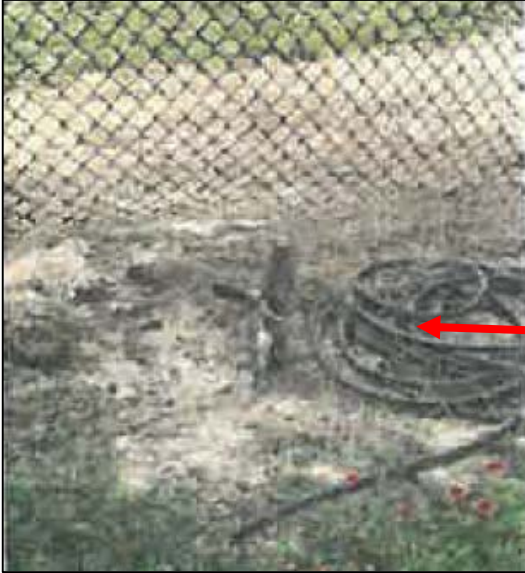
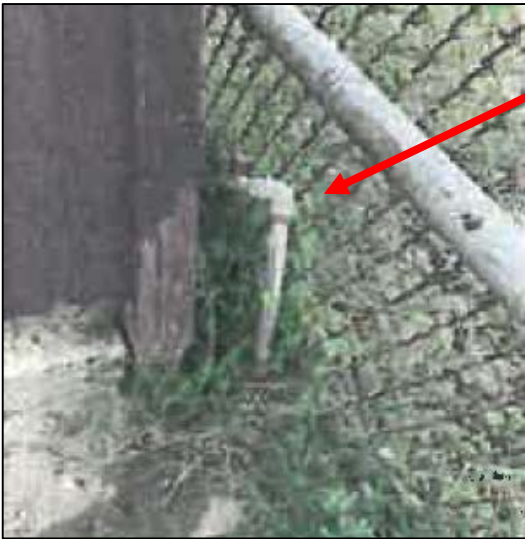
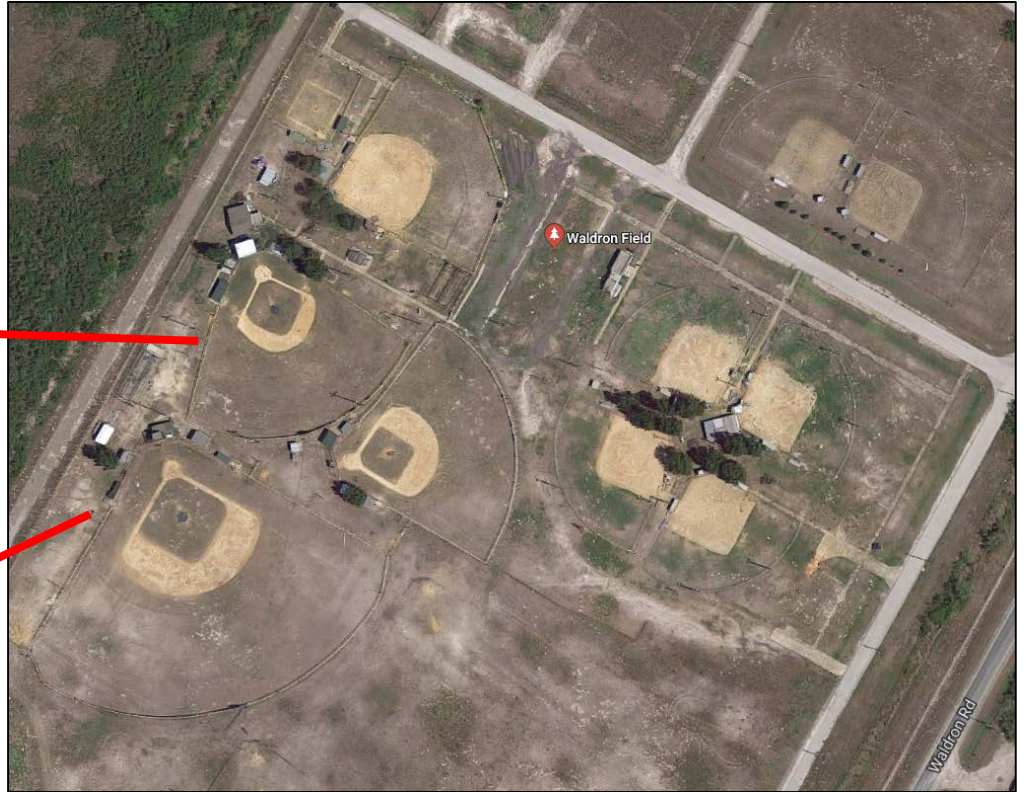
Figure 3

CC-PLAY-WALDRON-HOSE-I-FD (OPA-15)

CC-PLAY-WALDRON-HOSE-J-FD (OPA-16)

OPA-15 and OPA-16 LIPA Exceedance Locations
