# 2021 Annual Comprehensive Site Compliance Evaluation

**Naval Air Station Jacksonville, Florida**

*2021 Annual Inspections Conducted from 15 – 18 November 2021*

**2021 ANNUAL COMPREHENSIVE SITE  
COMPLIANCE EVALATION**

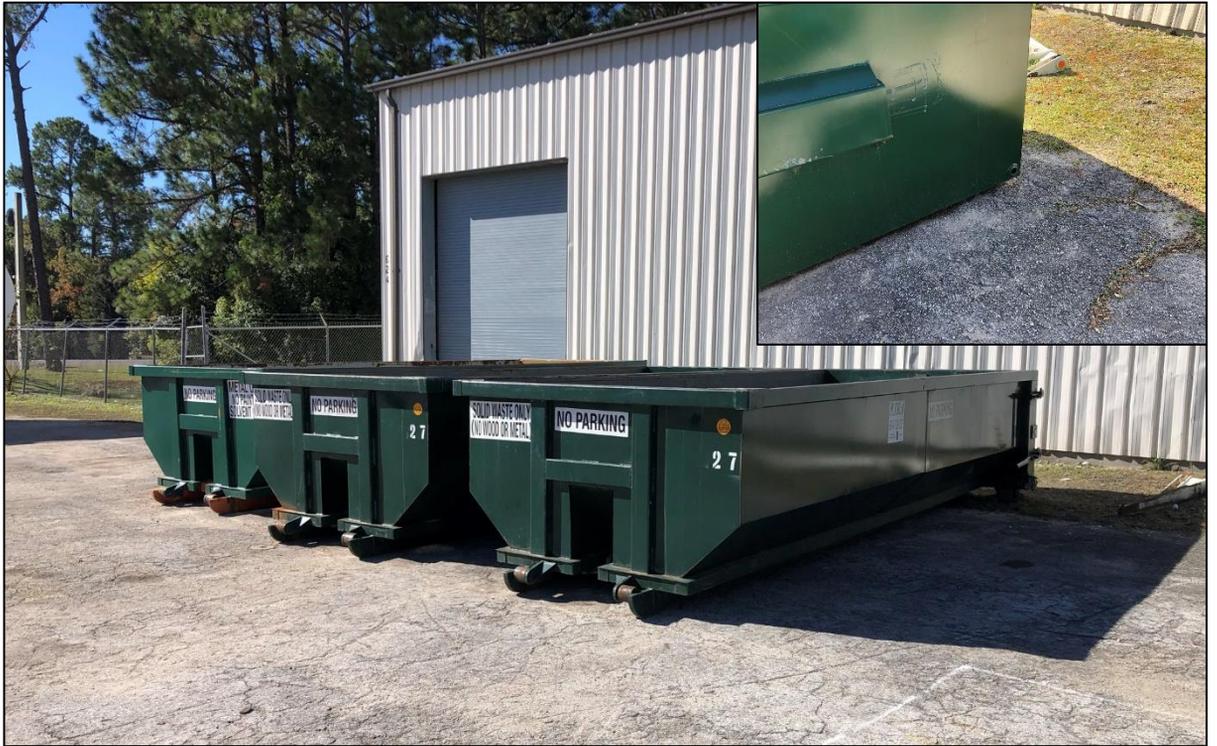
Uncovered roll-offs and missing drain plugs from dumpsters at the Recycling Facility.

- Facility is no longer managed by NAS JAX Morale, Welfare, and Recreation (MWR) and is now being operated by the recycling contractor Dorado Services, Inc.
- The facility was not in compliance with all requirements of the MSGP and the SWPPP. Observed deficiencies and recommended corrective actions are provided below:
  - The facility does not currently have a designated SWPPT member and trainings/inspections are not being conducted. A SWPPT member will need to be assigned for this facility. They will require SWPPP training and should begin conducting quarterly compliance inspections per the MSGP.
  - Some roll-off dumpsters were uncovered during inspection and multiple dumpsters were found to not have drain plugs. AH recommends covering all dumpsters when not in use and installing drain plugs on all dumpsters.

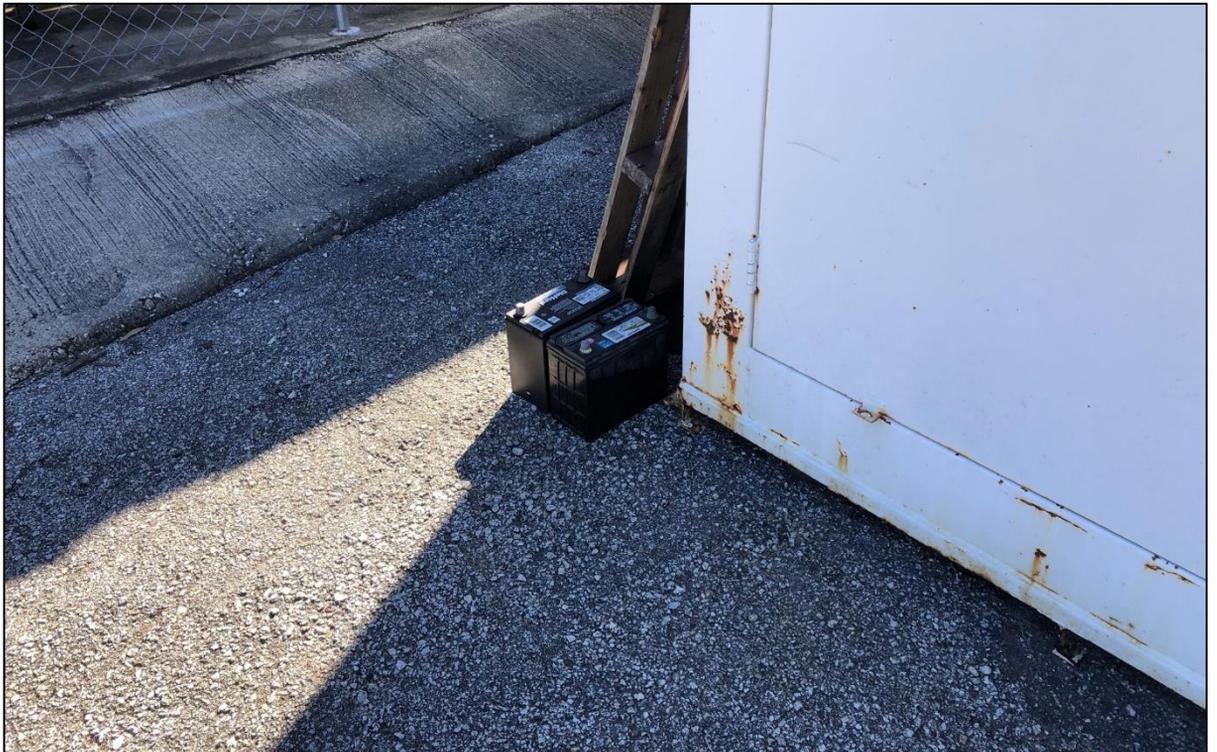
Vehicle batteries stored uncovered and outside their designated locker.

- Two vehicle batteries were stored on the ground outside of the designated locker. AH recommends storing vehicle batteries within the designated locker.

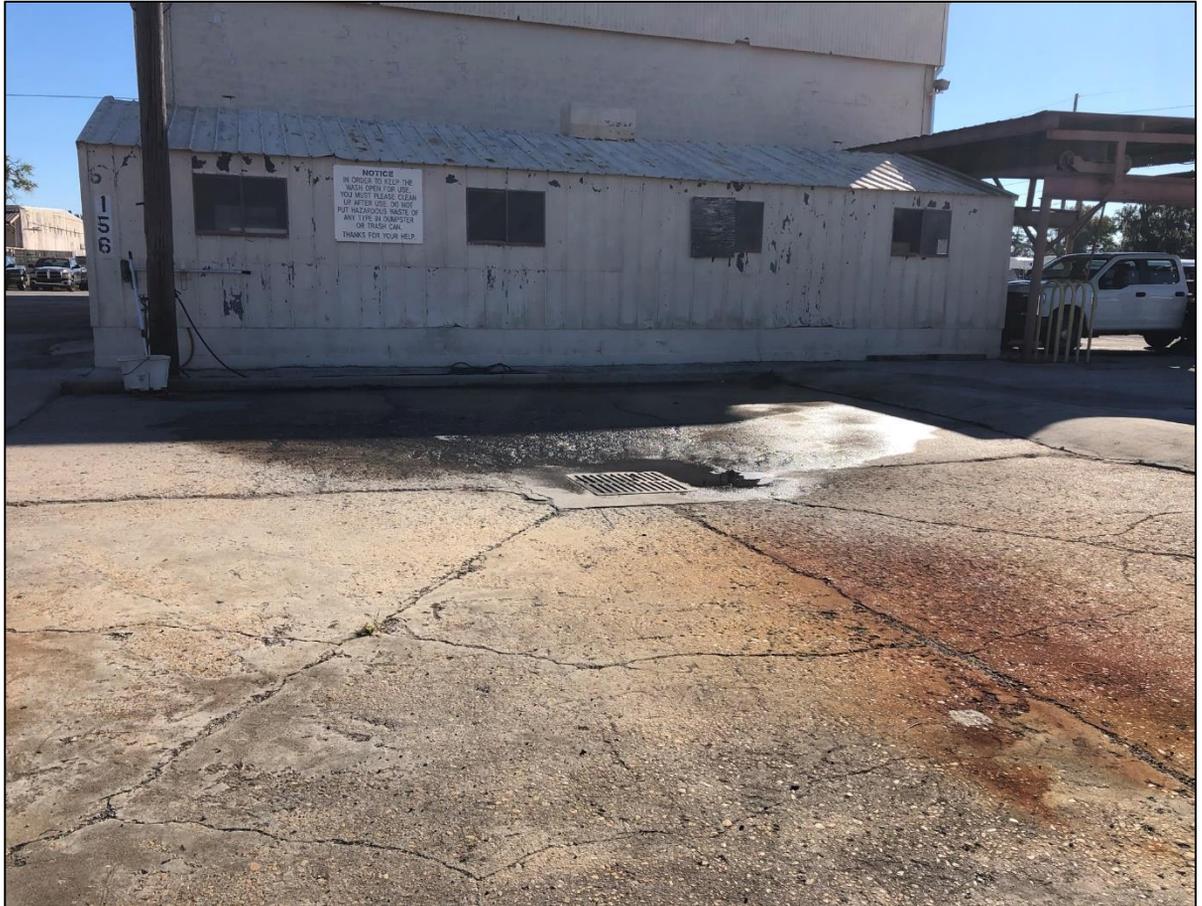
Cracks in vehicle wash rack concrete pad.

- The vehicle wash rack containment pad has multiple cracks, some of which have vegetation growing in them. AH recommends that the vegetation be removed and the cracks in the pad be sealed.
- Aside from the one minor observation noted above, this facility complied with the remaining requirements of the MSGP and the SWPPP.

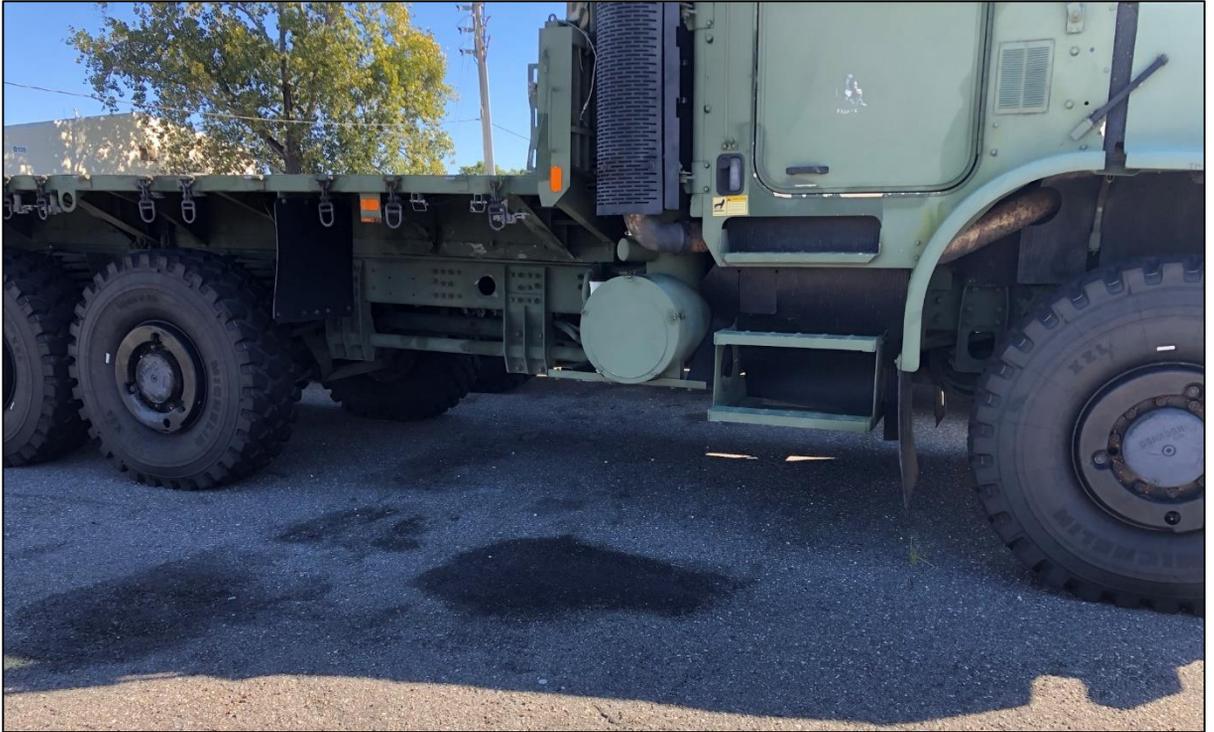
POL staining on pavement.

- One large POL stain was observed on the pavement. Overall, drips, leaks, and spills have been greatly improved since previous inspection. AH recommends that facility personnel continue to use drip pans for leaky vehicles and repair leaks promptly once discovered.
- Miscellaneous discarded equipment was stored outdoors and uncovered. AH recommends disposing of this equipment properly.
- Aside from the two minor observations noted above, the CBMU 202 facility complied with the requirements of the MSGP and the SWPPP. The wash rack valves were positioned in the correct configuration at the time of the CCE inspection. Additionally, facility personnel were properly educated regarding valve operations.

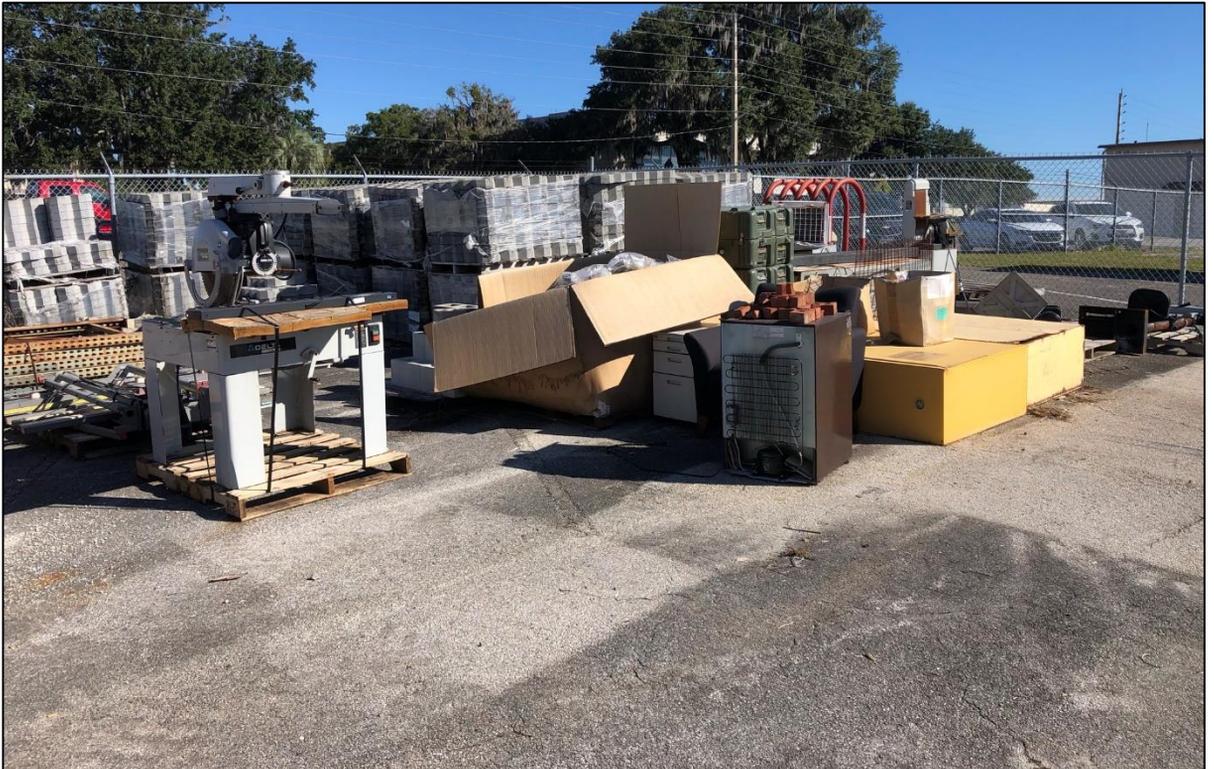
Miscellaneous discarded equipment stored outdoors and uncovered.

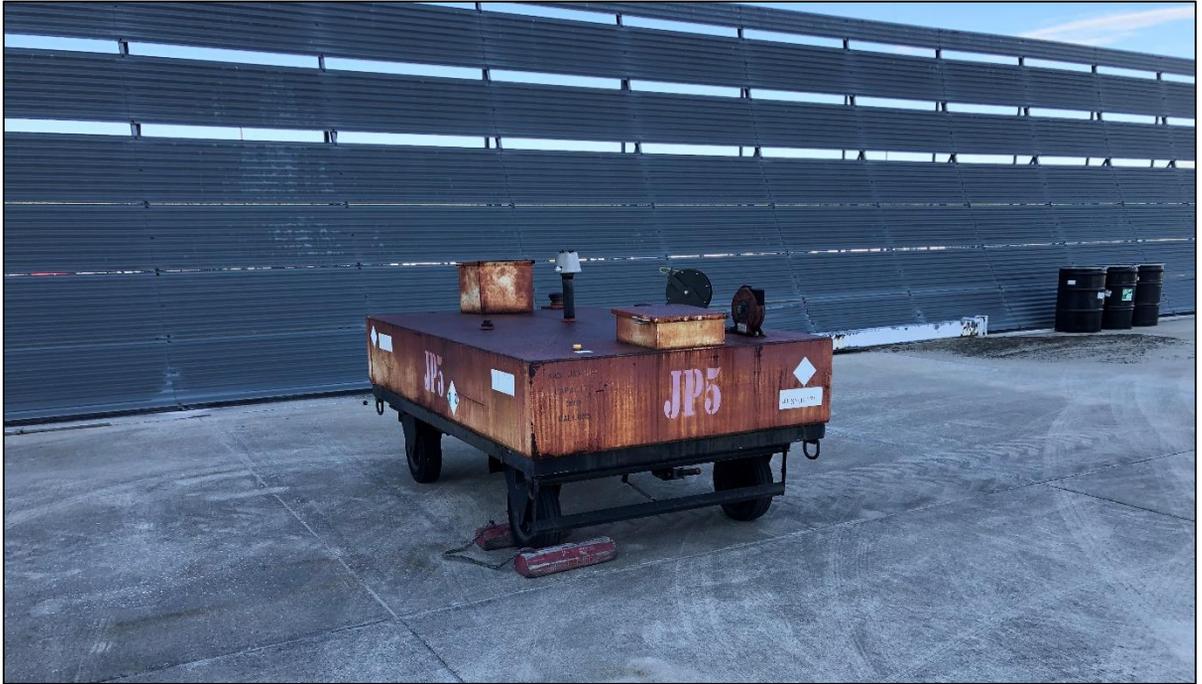
Heavily rusted fuel cart located on the west end of Hangar 511.

- The wheeled fuel cart located on the west side of Hangar 511 is heavily rusted and in poor condition. AH recommends properly disposing of and replacing this fuel cart.

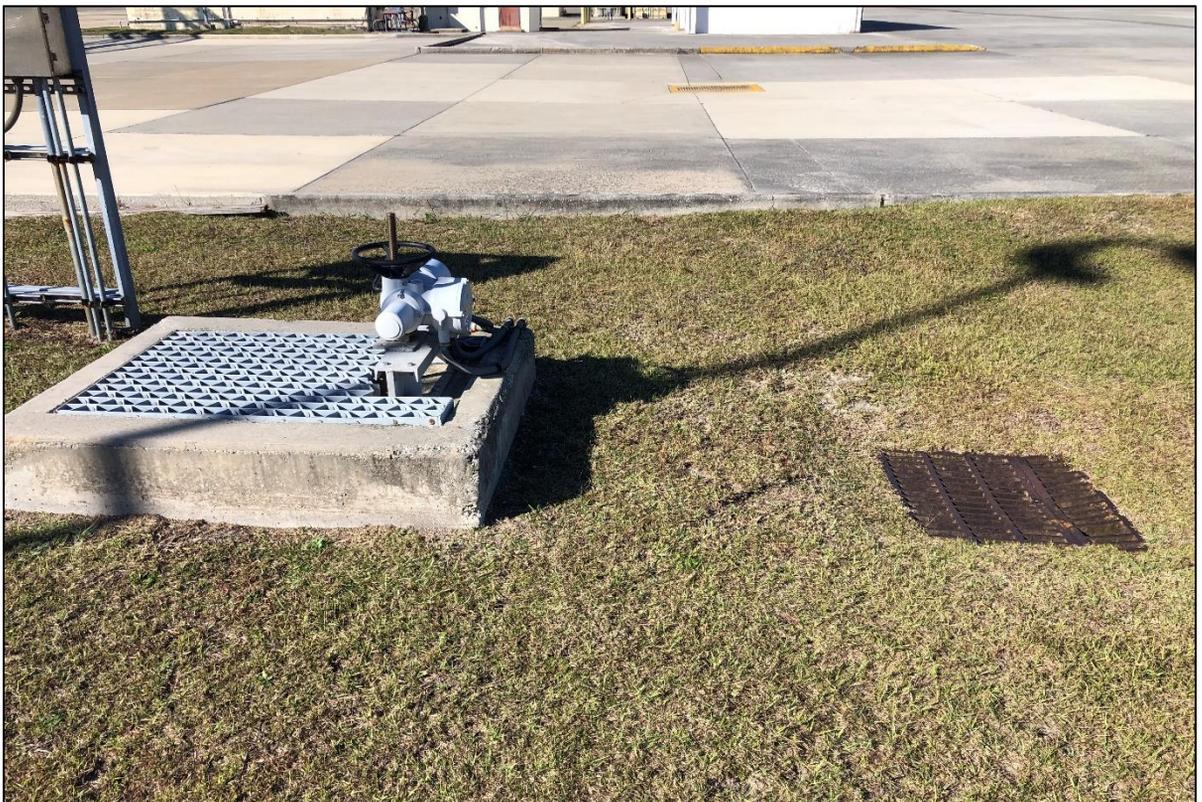
Aircraft wash rack diversion valve system was inoperable (all flows diverted to sanitary sewer).

- AH recommends repair of the automatic wash rack diversion valves (or replacement if necessary).
  - Additionally, AH recommends that personnel operating the wash rack are trained on proper wash rack operations/valve configurations.

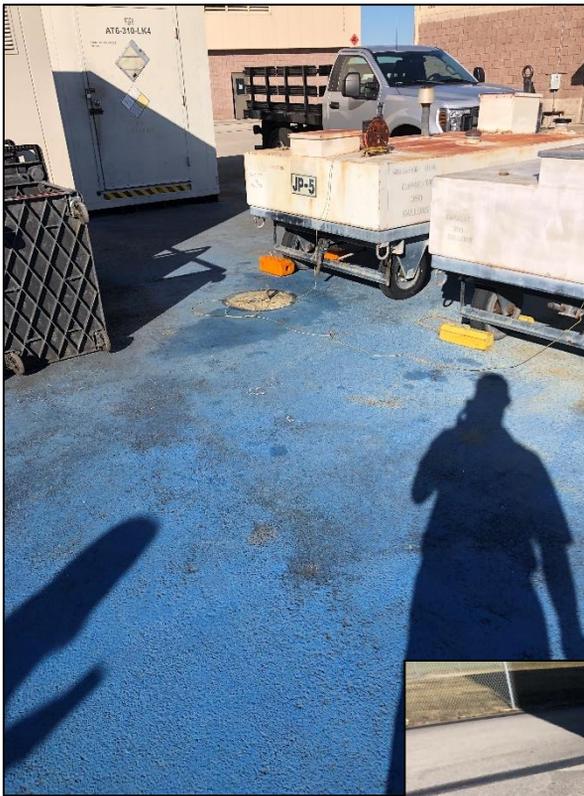
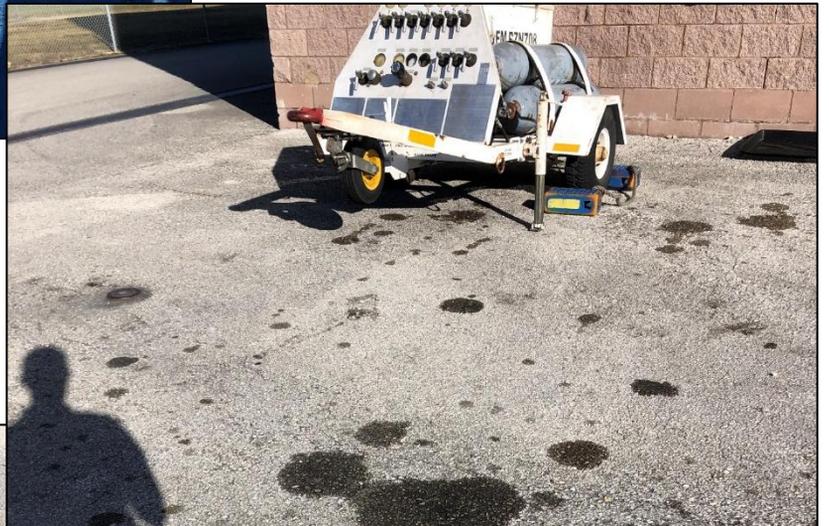
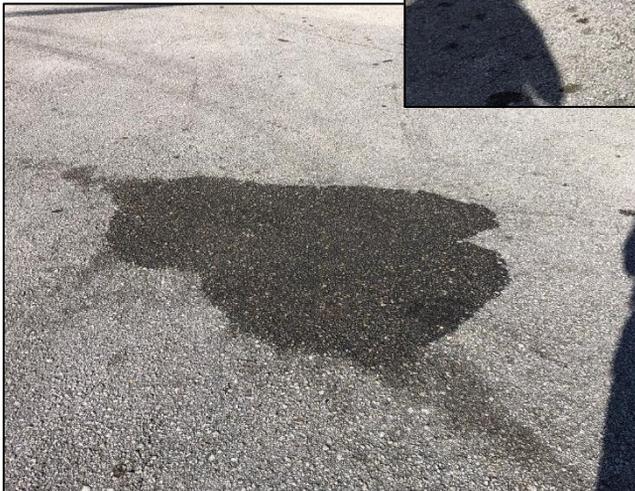
Various POL stains and drips throughout facility.

- The inspection team noted multiple POL stains near the southwest corner of Hangar 30 and on the east side of the hangar near the fueled equipment storage area. The facility should implement proper use of drip pans and prompt repair of any leaking equipment/vehicles at all times to prevent further staining and spills/leaks.
- An unlabeled, single-walled AST associated with the fire suppression system was located outdoors, along the east side of the hangar. AH recommends labelling this AST properly and determining if secondary containment is required for the stored liquid.
- Aside from the noted POL stains and unlabeled AST, this facility complied with all other requirements of the MSGP and the SWPPP.

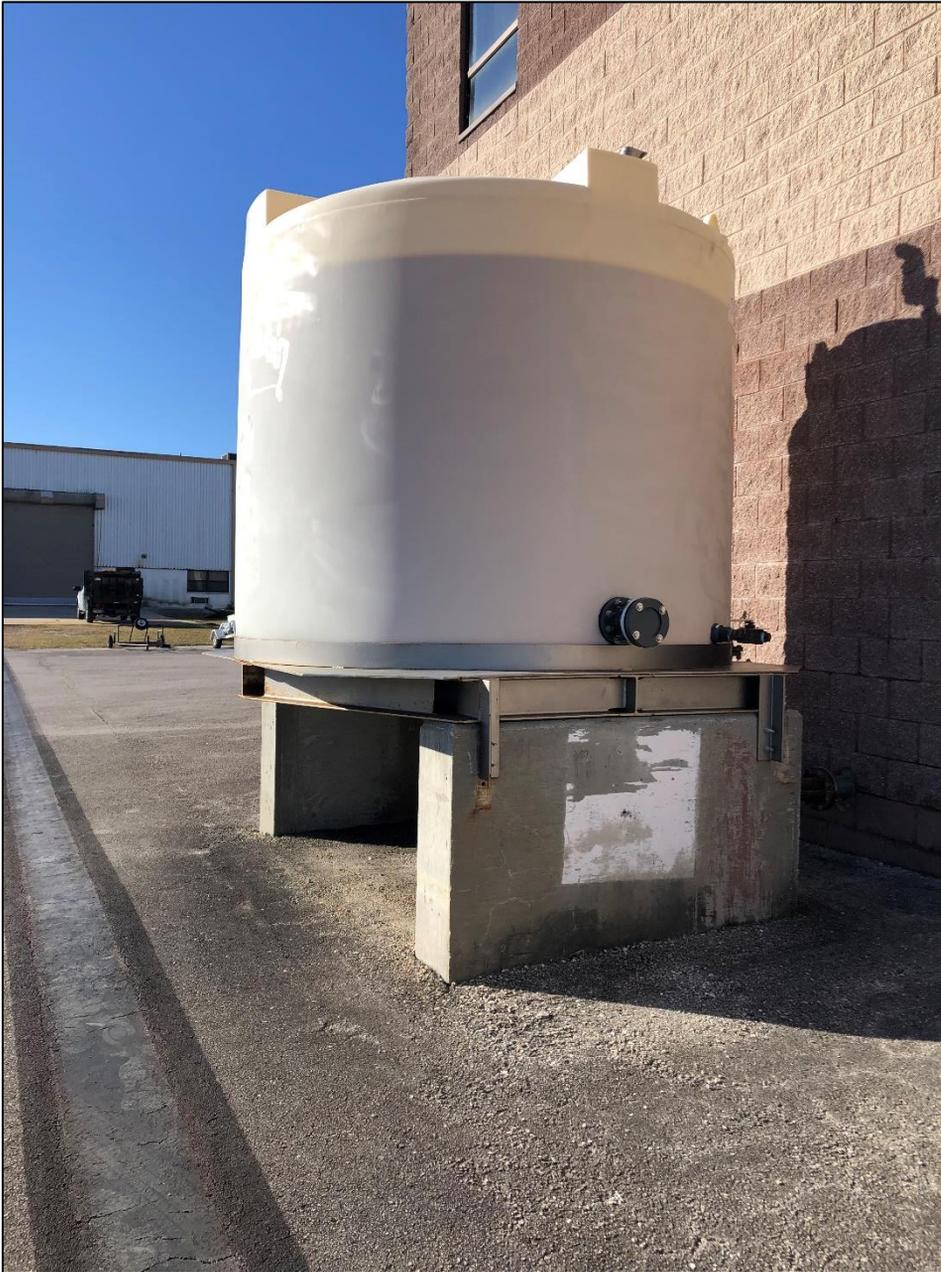
Unlabeled fire suppression AST (single-walled).

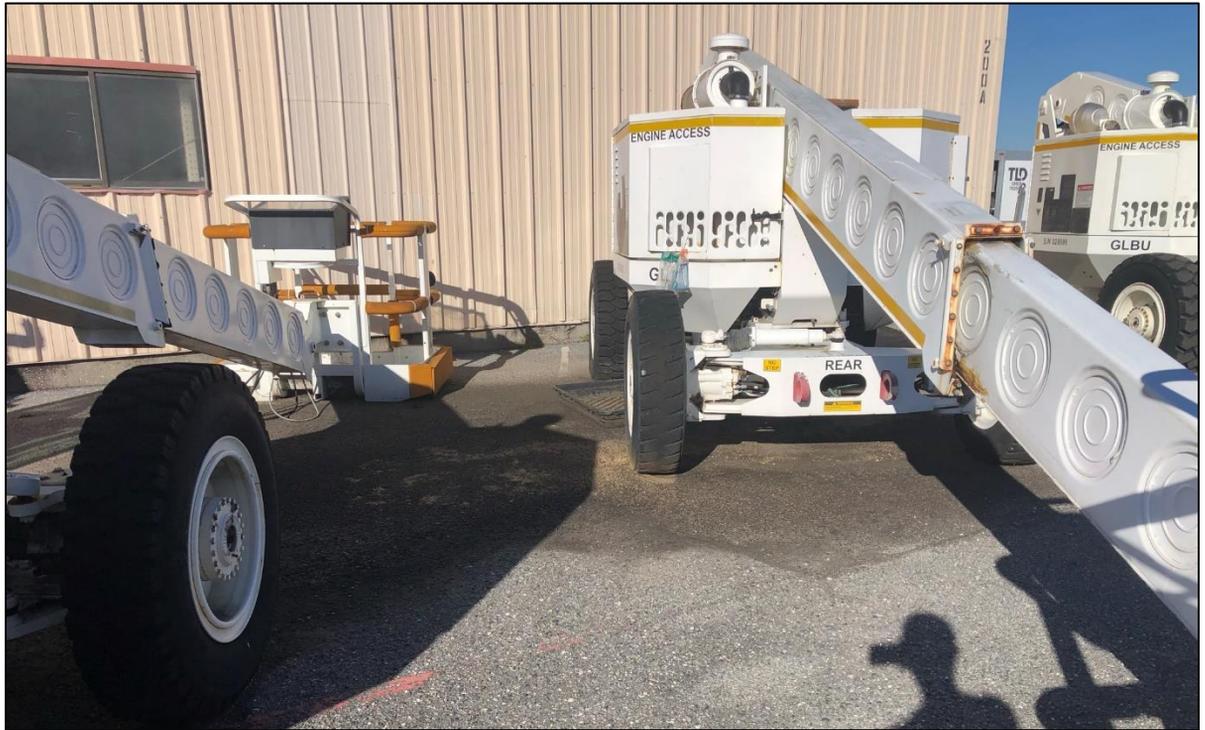
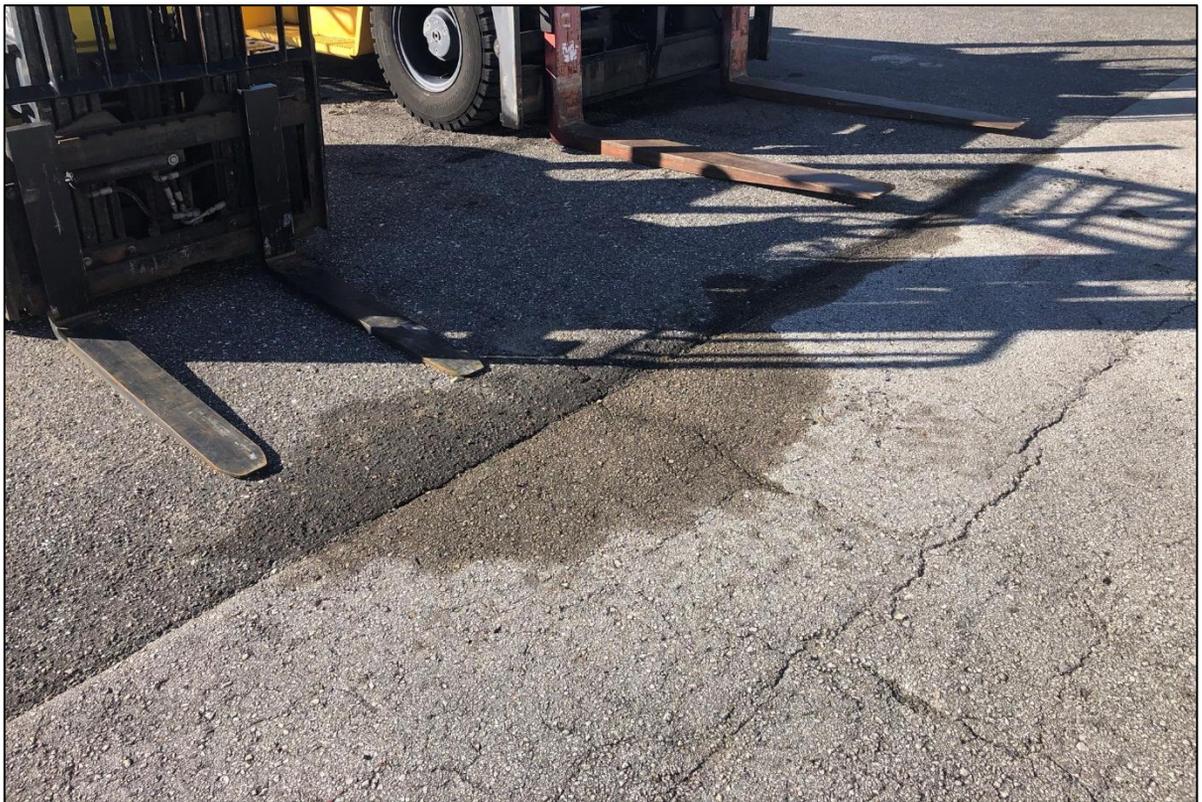
Various large POL stains and drips throughout facility.

- The field team observed several large POL stains on the pavement. AH recommends that facility personnel use drip pans for leaky vehicles and repair leaks promptly once discovered. This is a recurring finding from previous CCE inspections.
- The facility was not in compliance with all requirements of the MSGP and the SWPPP.

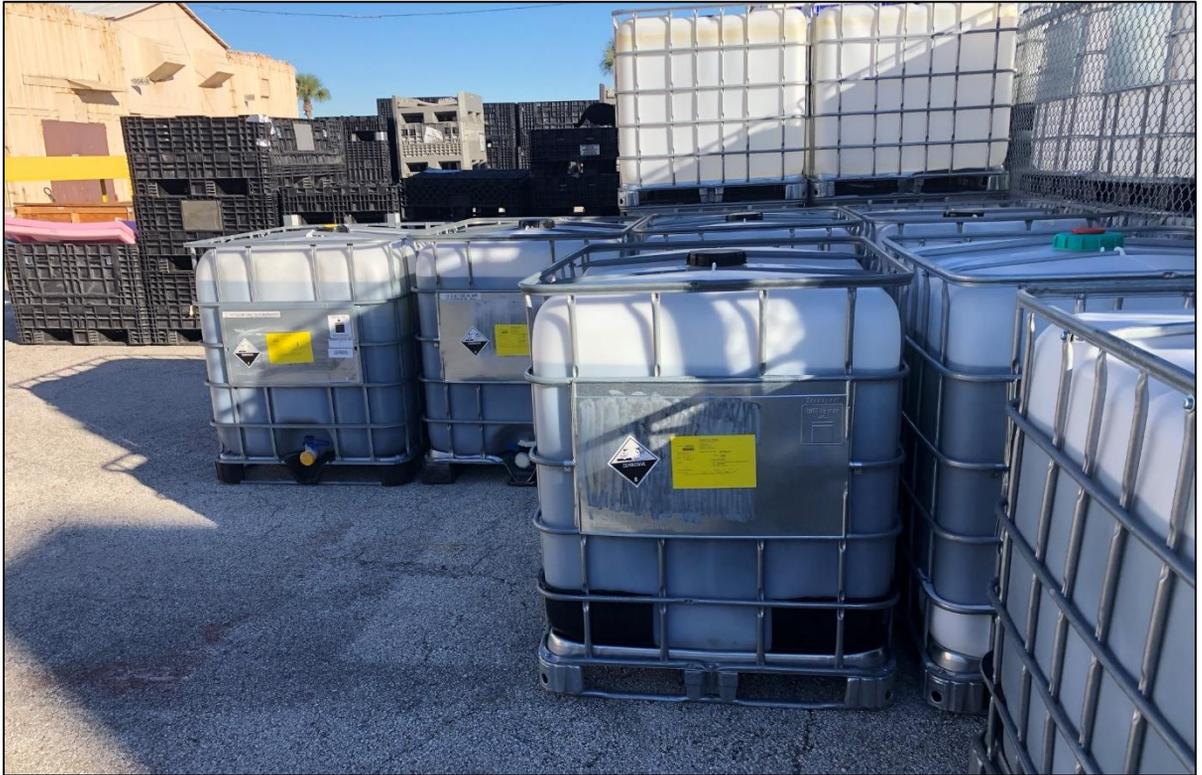
Figure  
B-8

**Hazardous Waste**

**FRCS Building 101R**  
**2021 Comprehensive Site Compliance Evaluation**  
 NAS Jacksonville, Florida

- Building 101R is the HW accumulation site for FRCSE. The field team observed that many 55-gallon drums and chemical totes were stored outside with no secondary containment or cover. Additionally, these containers were stored in close proximity to a stormwater drain. Any spilled HW in this area would quickly discharge straight to the stormwater system. AH recommends moving all 55-gallon drums and chemical totes indoors or to areas with adequate secondary containment.

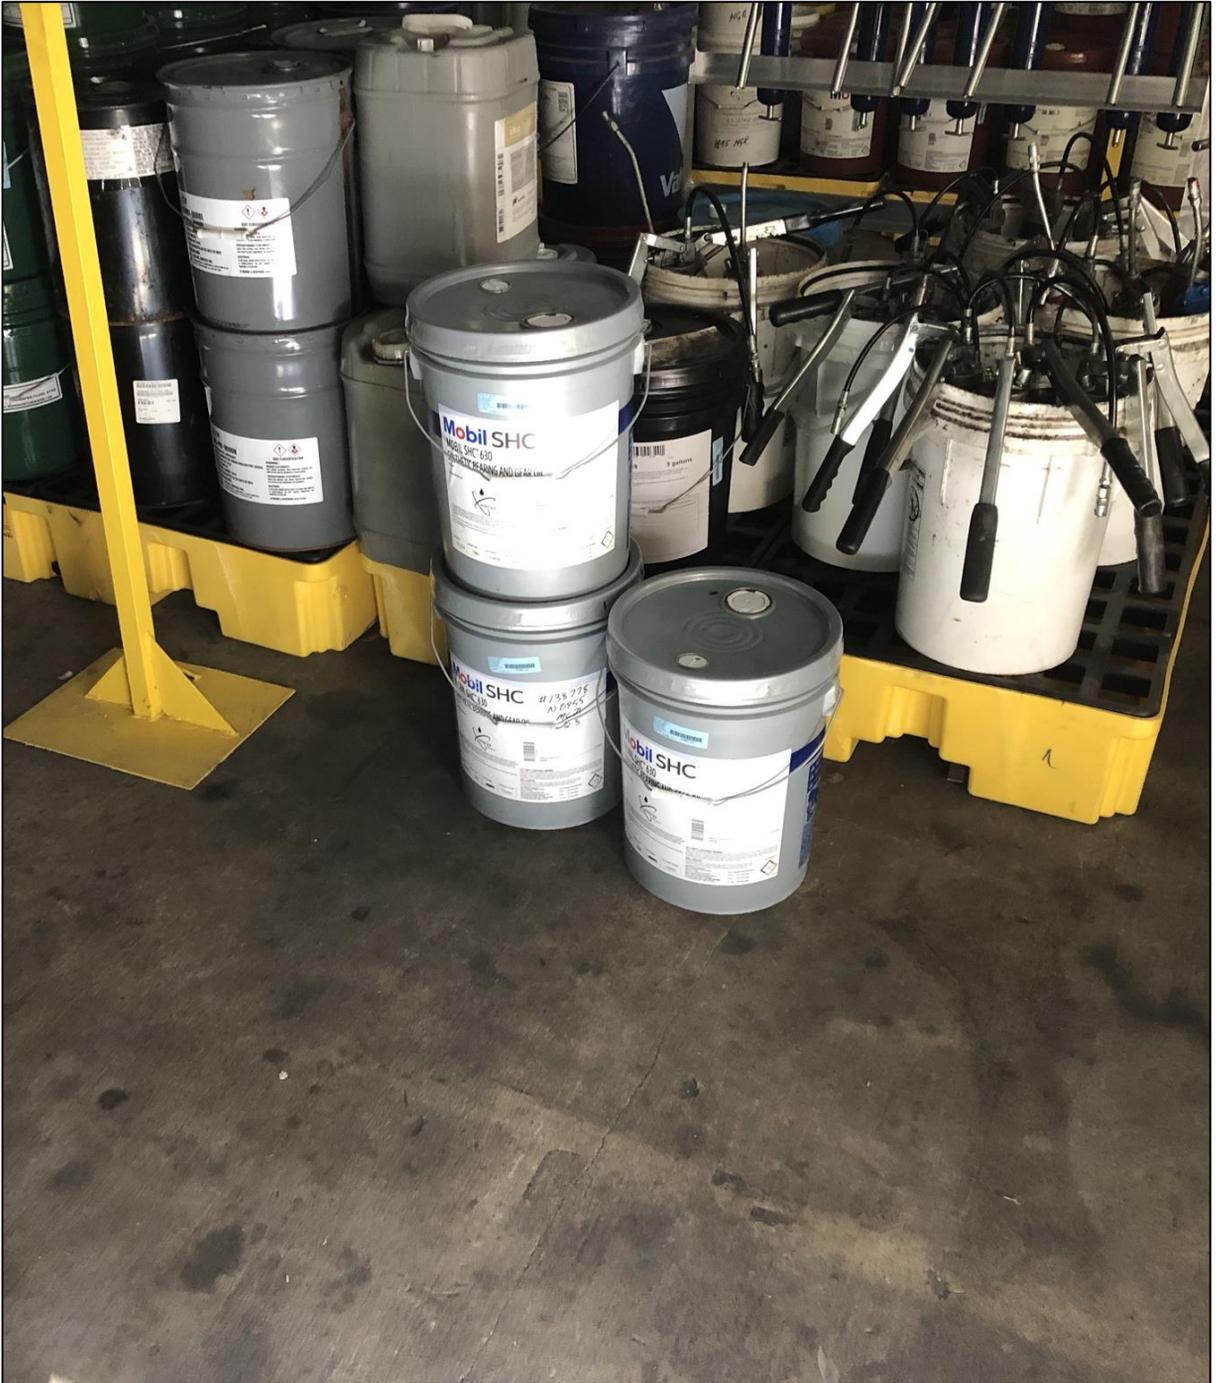
HM/HW containers stored without secondary containment in Building 158 (storm drains located inside building).

- Building 158 serves as an indoor HM/HW storage building and contains indoor storm drains. The majority of HM/HW is stored within secondary containment; however, the inspection team noted some HM containers that were stored without containment near the drains. AH recommends ensuring secondary containment for all HM/HW containers within the building to prevent any potential spills into the storm drains.

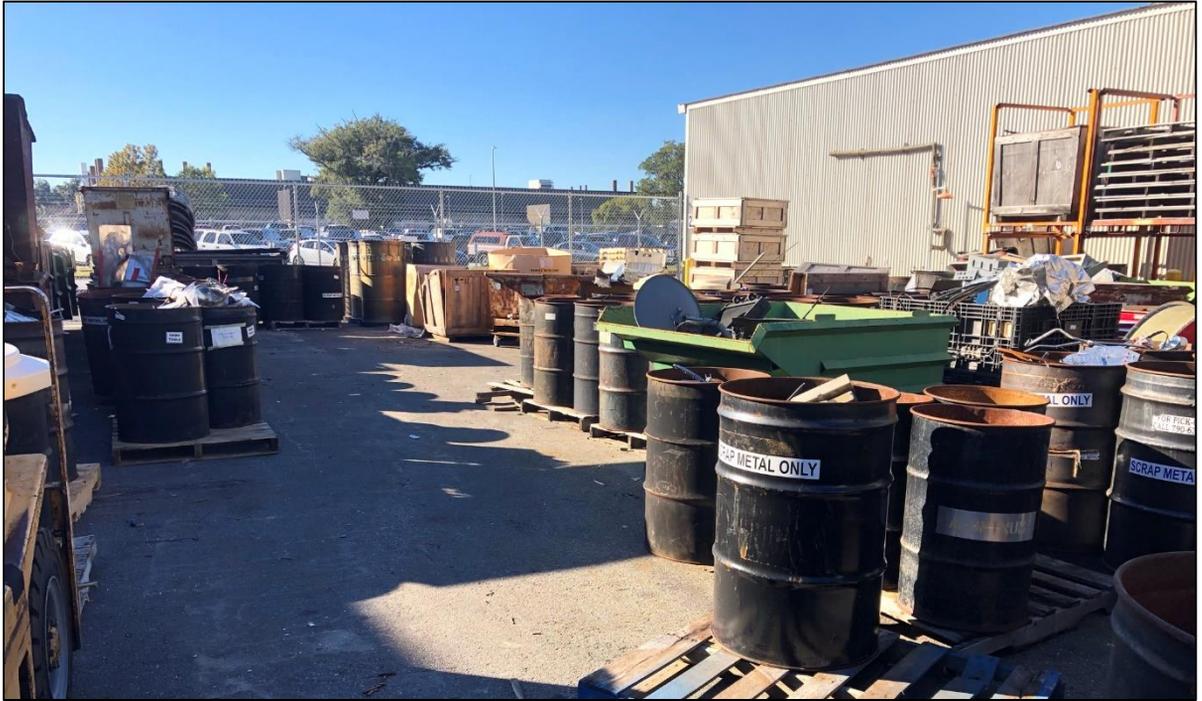
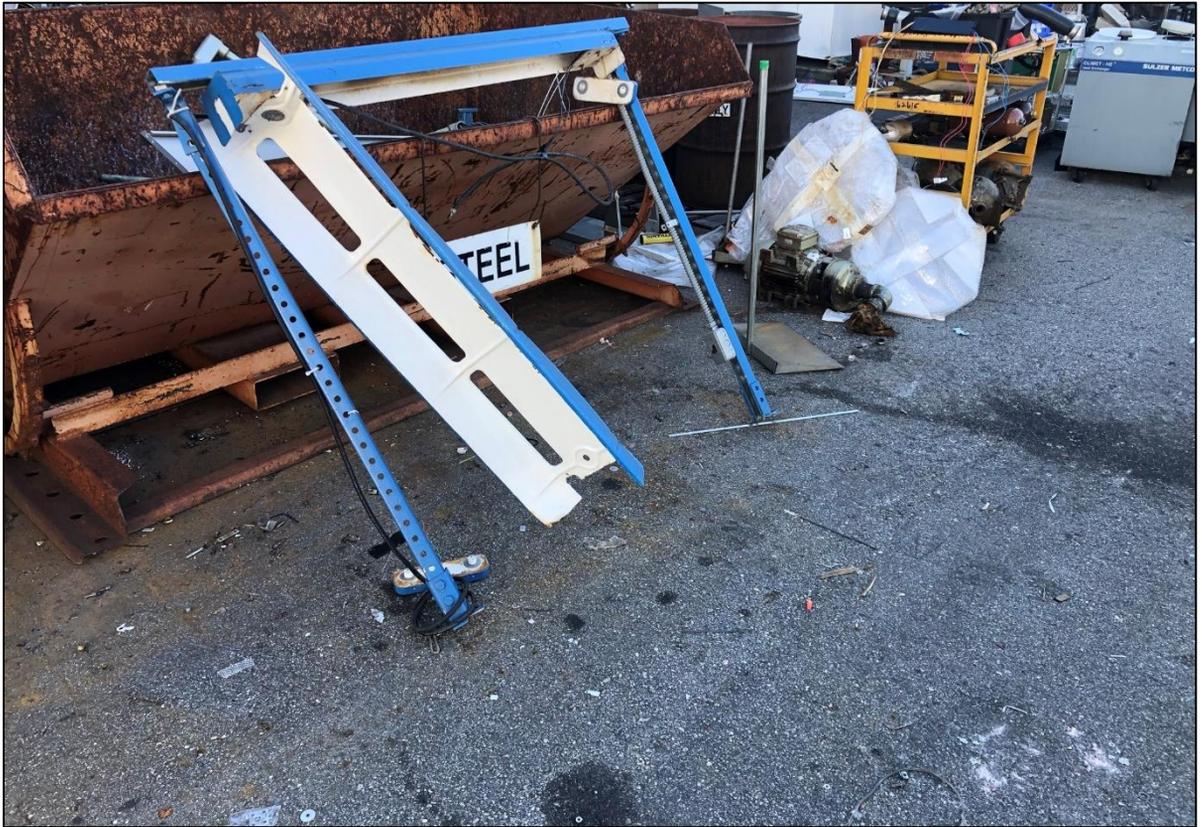
General housekeeping issues throughout the FRCSE scrapyard.

- The inspection team noted several general housekeeping issues at the FRCSE Hangar 101 scrapyard. Trash, debris, metal shavings, and other miscellaneous metals were scattered and unorganized throughout the yard. Protocols are in place to have liquid and filters removed from equipment prior to it being scrapped; however, the FRCSE SWPPT member noted that these requirements are not always followed. AH recommends ensuring that the engine disposal protocols are more consistently followed and clearly posted at the facility. Additionally, improved housekeeping throughout the scrapyard area is recommended.

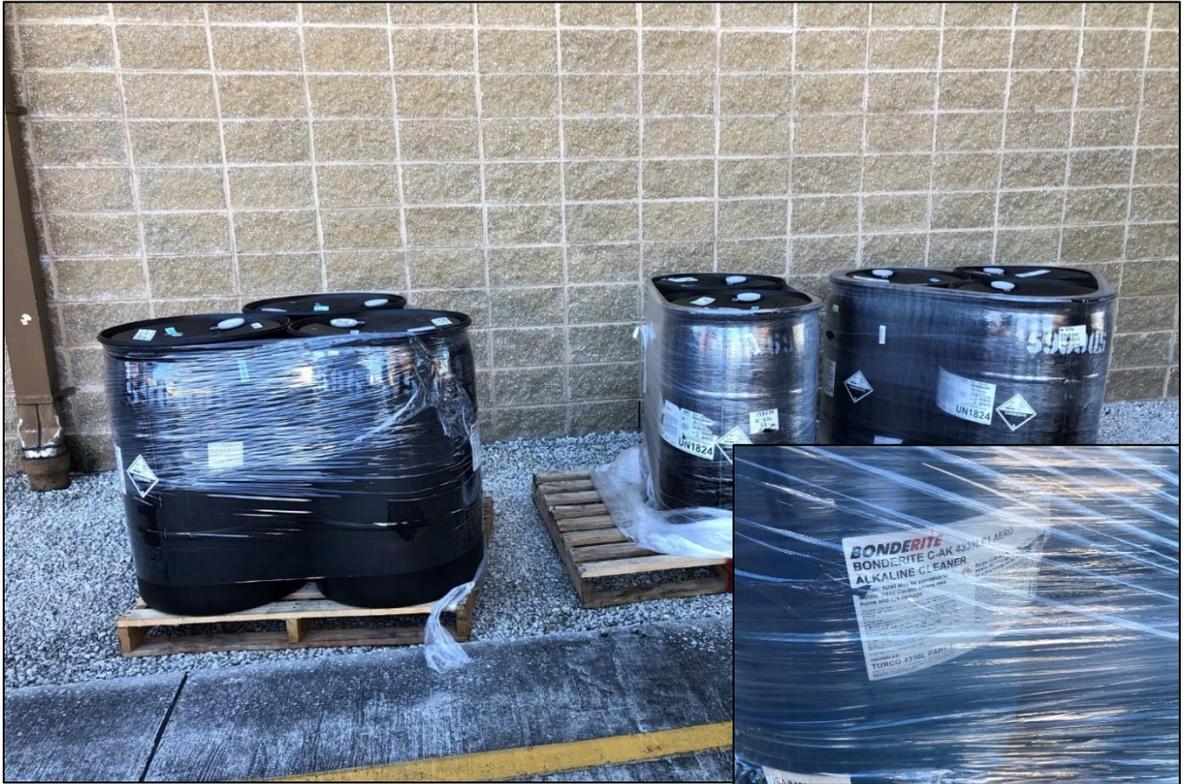
Multiple drums of cleaner stored outside Building 794 without secondary containment.

- Multiple 55-gallon drums of a chemical cleaner solution were stored outside Building 794 (plating shop) without secondary containment. Additionally, multiple chemical totes containing engine washing wastewater were stored outside Building 797 (engine processing and repair facility) with no secondary containment. AH recommends providing secondary containment for all drums and totes (or moving the drums/totes indoors if possible).

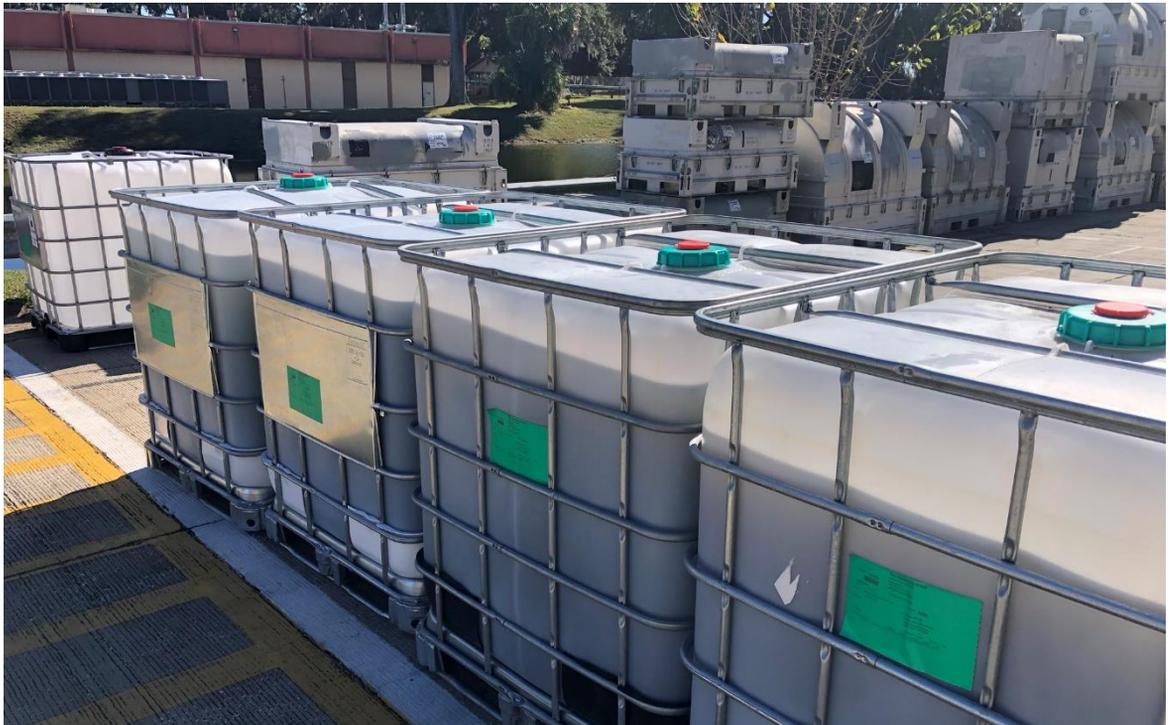
Multiple totes of engine washing wastewater stored outside Building 797 without secondary containment.
