INDOOR AIR QUALITY ASSESSMENT REPORT

**ENVIRONMENTAL INVESTIGATION
OFFICE OF MILITARY COMMISSIONS
CAMP JUSTICE — NAVAL STATION GUANTANAMO BAY, CUBA**

12 January 2016

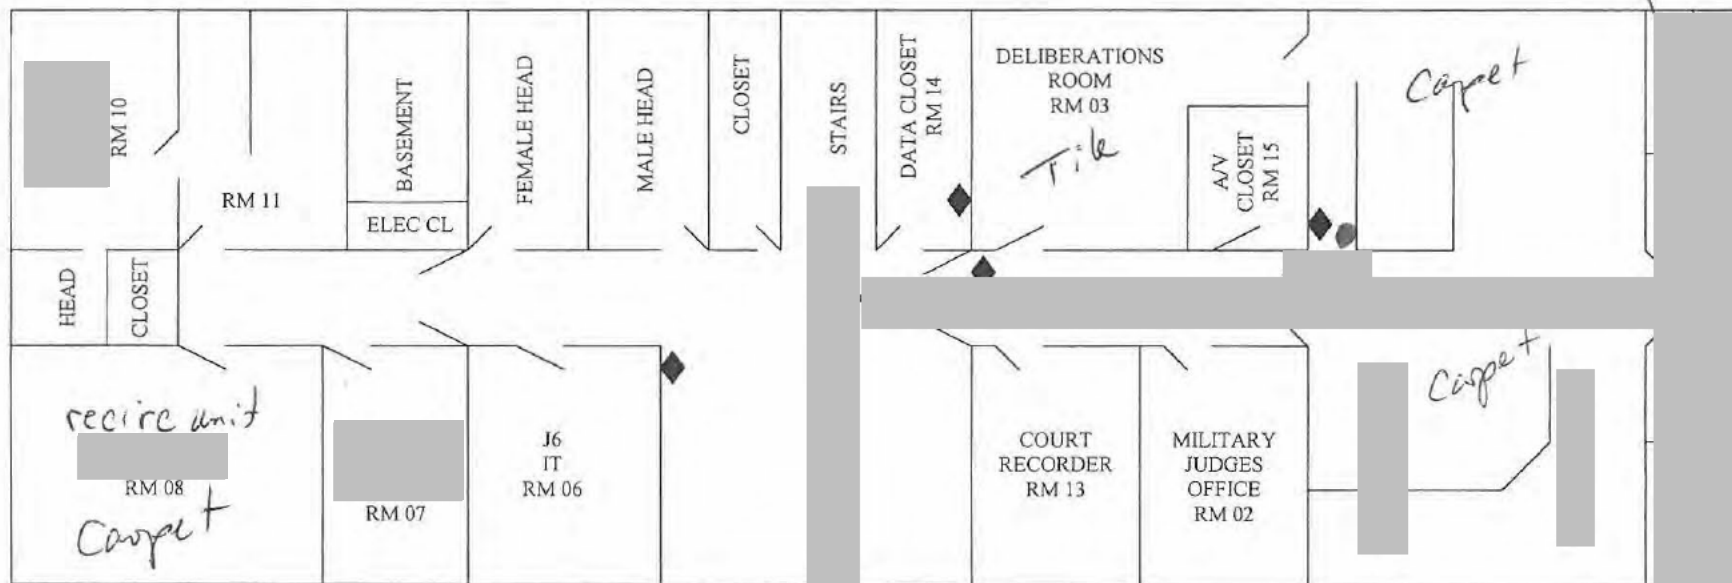
AV-34

insulated drop ceiling with 3" of insulation on underneath
